Report 03.146
Date 18 March 2003
File B/09/02/02

Possible Kaitoke Water Main Diversion - State Highway 2 to State Highway 58

Kaitoke Main SH2 to SH58 Seismic Risk Assessment Executive Summary

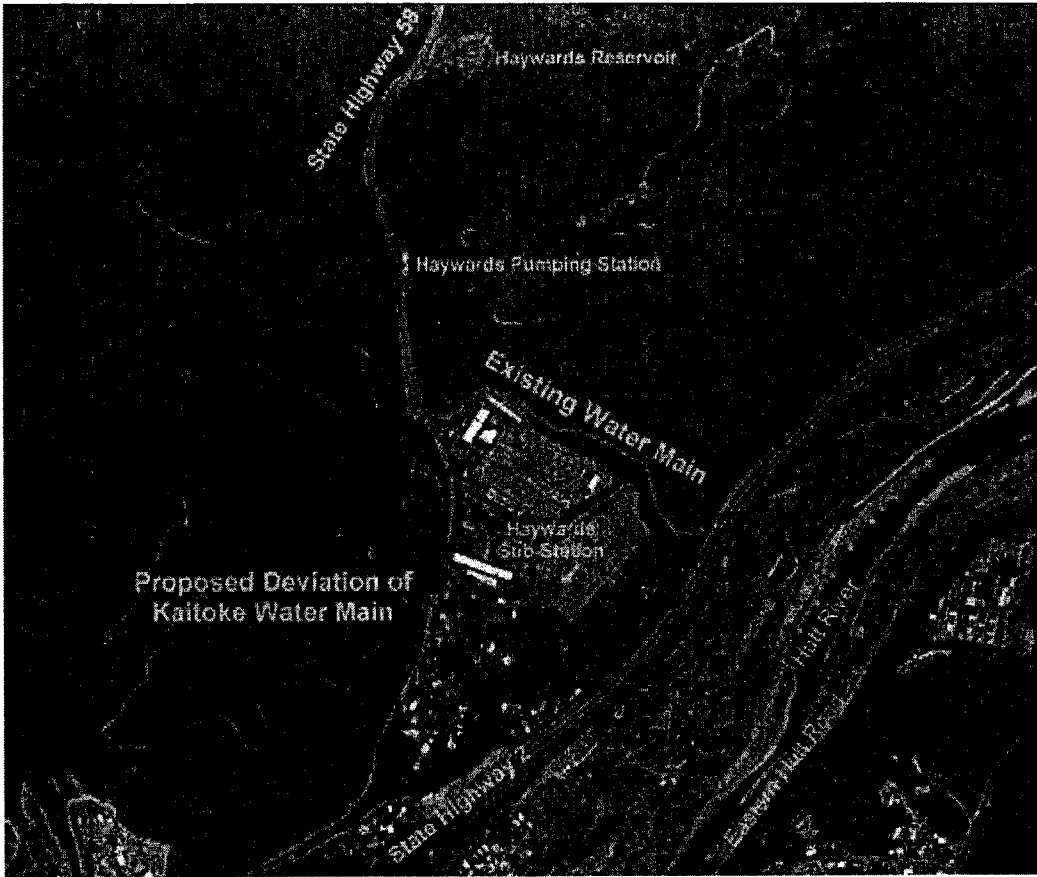
An alternative route following SH58 has been investigated and \$1.8 million programmed in the draft capital works programme in 04/05 to construct a new water main along this route. The existing water main alignment and proposed diversion are shown in Figure 1.

Figure 1 : Existing and proposed diversion of the Kaitoke Main.

A 1500 metre water main diversion, as shown in Figure 1 between SH2 and SH58 has been investigated. \$1.8 million is allocated in the draft capital works programme in 2004/05 to construct the diversion. The proposed water main route continues south of Old Haywards Hill Road along SH2 and McDougall Grove, west along a short section of walkway then up a steep slope at the head of a gully and north along the uphill side of SH58 to join with the existing main at the top of the Old Haywards Hill Road.

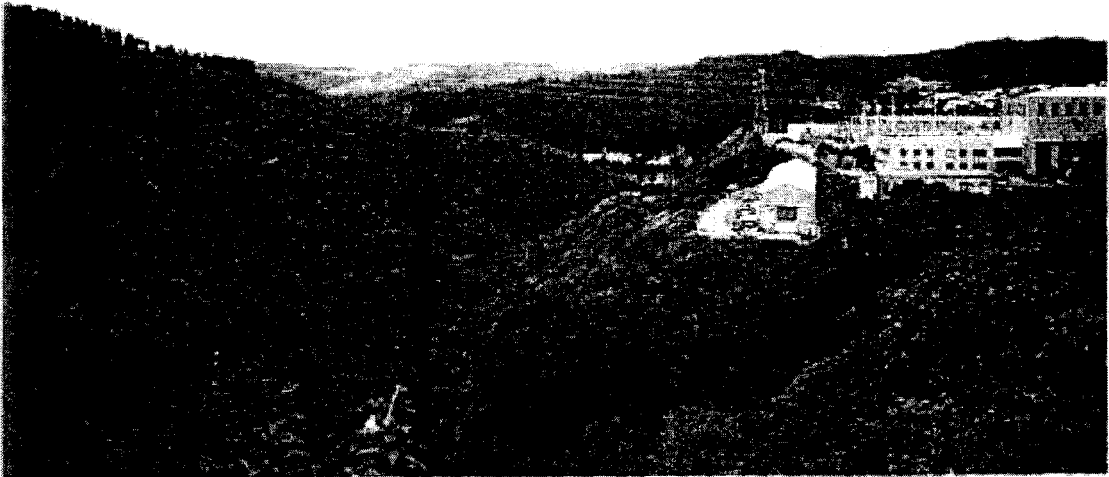
Figure 2 : Steep terrain along Old Haywards Hill Road portion of WaterMain (on hillside below Hayward substation).

The Old Haywards Hill Road runs across steep weathered greywacke rock terrain. Gullies have been formed by preferential erosion in the rock, and some gullies have been partially filled in with eroded material (colluvium). Colluvium has also been deposited on slopes at some locations. Weathering of the greywacke rock has also occurred.

The colluvium is more susceptible to instability than the parent rock. Where the colluvium predominates, a number of slips have occurred below the road indicating these areas are marginally stable. A rise in water level after prolonged rainfall may be sufficient to cause instability at these locations, with or without seismic loads.

The Old Haywards Hill Road has been formed by cutting into the side of the steep hill. It is probable that the outer section of the road is constructed from fill material placed on the slope. Crib retaining walls have been used to retain the ground above the road in some areas, indicating the presence of potentially unstable material.

The major hazard to the existing watermain is landslides resulting from seismic shaking acceleration, which will result in damage to, or complete loss of, the water main, and severely limit access to effect repairs.
