Report **03.146**
Date 18 March 2003
File B/09/02/02

Possible Kaitoke Water Main Diversion - State Highway 2 to State Highway 58

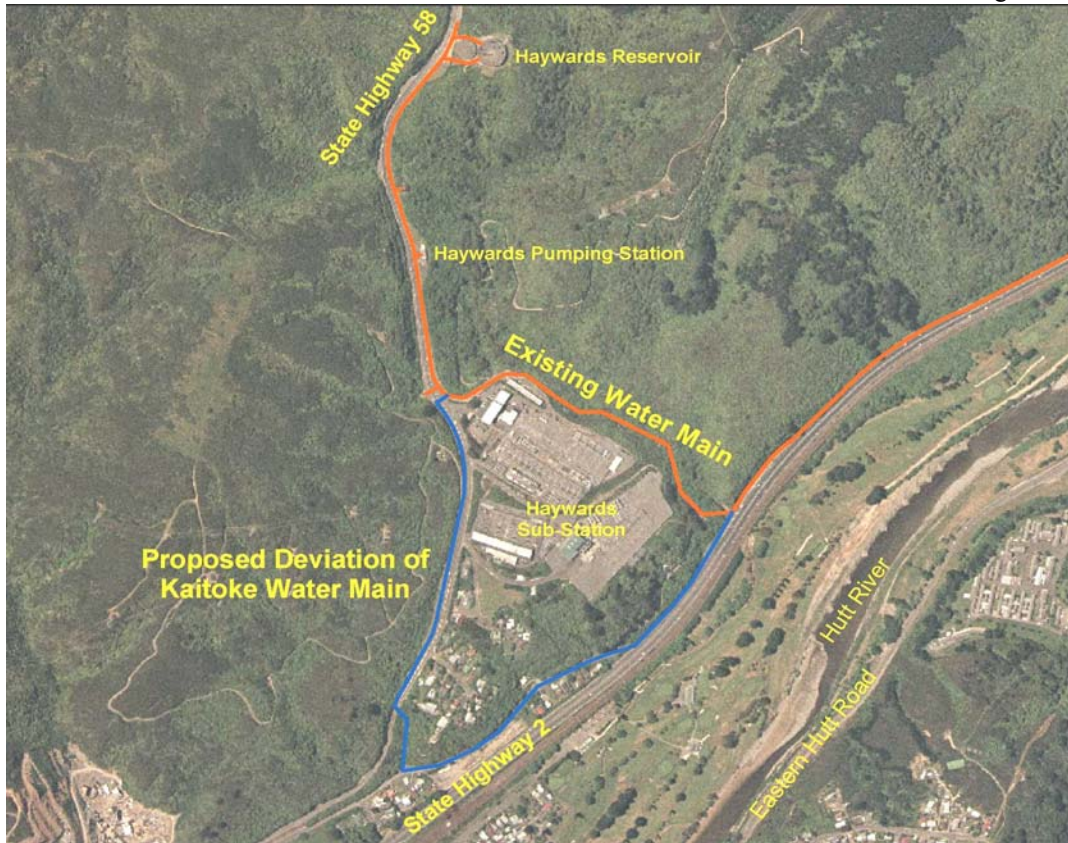
Figure 1 : Existing and proposed diversion of the Kaitoke Main.

A 1500 metre water main diversion, as shown in Figure 1 between SH2 and SH58 has been investigated. \$1.8 million is allocated in the draft capital works programme in 2004/05 to construct the diversion. The proposed water main route continues south of Old Haywards Hill Road along SH2 and McDougall Grove, west along a short section of walkway then up a steep slope at the head of a gully and north along the uphill side of SH58 to join with the existing main at the top of the Old Haywards Hill Road.

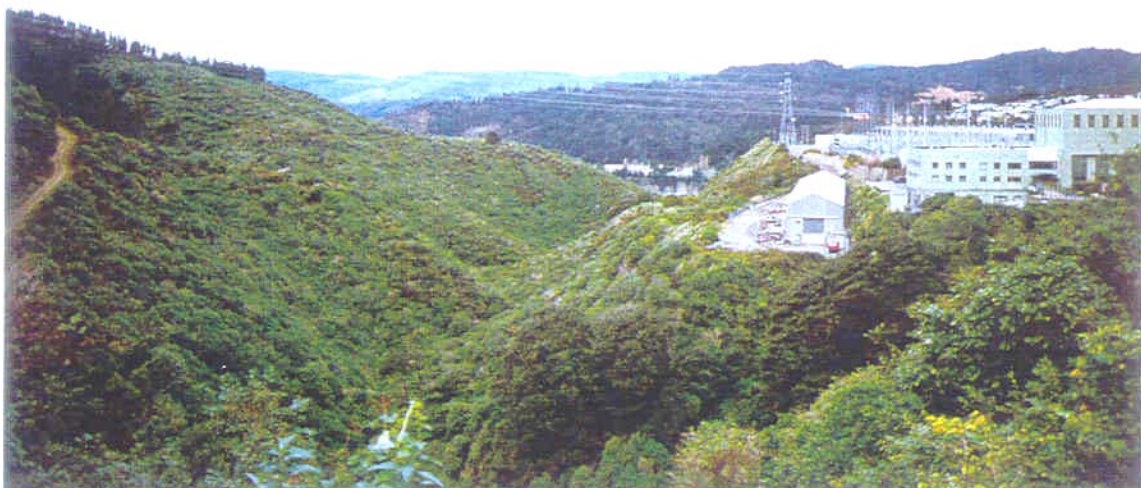
Figure 2 : Steep terrain along Old Haywards Hill Road portion of Water Main (on hillside below Haywards substation).

The Old Haywards Hill Road runs across steep weathered greywacke rock terrain. Gullies have been formed by preferential erosion in the rock, and some gullies have been partially filled in with eroded material (colluvium). Colluvium has also been deposited on slopes at some locations. Weathering of the greywacke rock has also occurred.

The colluvium is more susceptible to instability than the parent rock. Where the colluvium predominates, a number of slips have occurred below the road indicating these areas are marginally stable. A rise in water level after prolonged rainfall may be sufficient to cause instability at these locations, with or without seismic loads.

The Old Haywards Hill Road has been formed by cutting into the side of the steep hill. It is probable that the outer section of the road is constructed from fill material placed on the slope. Crib retaining walls have been used to retain the ground above the road in some areas, indicating the presence of potentially unstable material.

The major hazard to the existing watermain is landslides resulting from seismic shaking acceleration, which will result in damage to, or complete loss of, the water main, and severely limit access to effect repairs.
