# Investigation into Stormwater Contamination from the Exide Technologies Reprocessing Plant, (51-57 Waione Street, Petone)

## FINAL REPORT

Pollution Control Team Report (Resource Investigations Department)  
Greater Wellington Regional Council (26 July 2005)

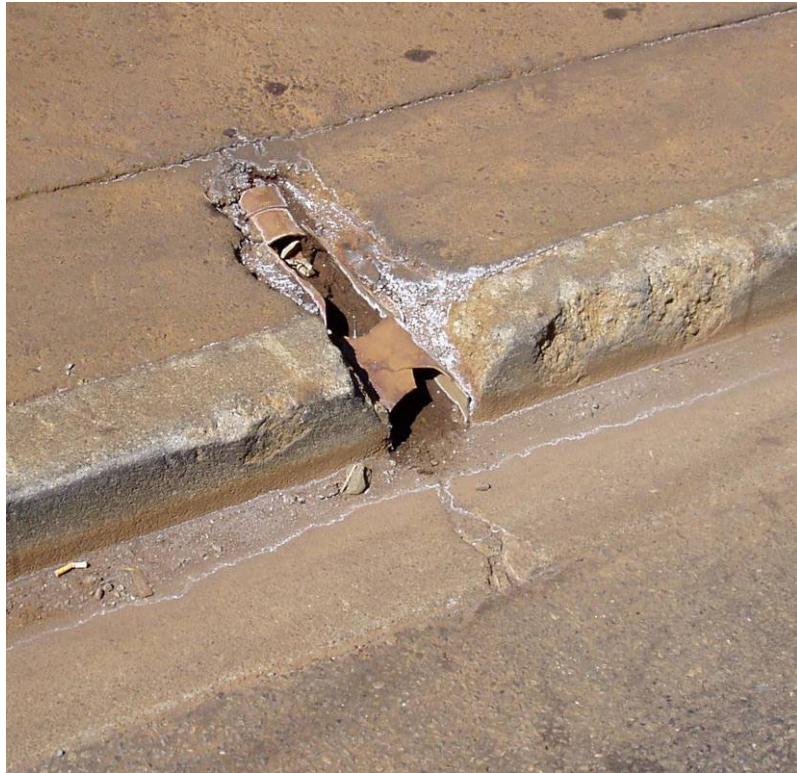
#### **Photo 1 Stormwater Drain from Roof of Exide Technologies (10/12/04)**

- Fugitive emissions falling onto roof surfaces above the battery recycling plant, entering roadside drains (see Photo 1).
- Insufficient cleaning of outdoor surfaces on the East Street side of the site, enabling metallic debris to enter roadside drains (see Photo 2).
- Corrosive material spillage onto yard surfaces at Exide Technologies, entering the stormwater system in East Street, as evidenced by corroded concrete, surface staining and acidic stormwater in East Street (see Photos 3 & 4).
- Process water escape to East Street via doorways. For example, the incident on 15 December 2004 resulted in a significant discharge of contaminants from the slag reprocessing area floor into the Te Mome Stream via the stormwater system (see Photos 5 & 6).

Although battery recycling operations at Exide Technologies involve the use of acid and lead, these results do not confirm Exide Technologies as the source of the acidity and lead contamination found in street sediments and stormwater in East Street. Photographs 1, 2 and 5 (see section 1) indicate that the Exide Technologies site is contributing liquid and particulate contaminants to East Street. Photograph 3 indicates that acidic liquid may also have discharged into East Street from the Exide site, although there is nothing to confirm that such discharges caused the highly acidic conditions found in a nearby stormwater sump in East Street.

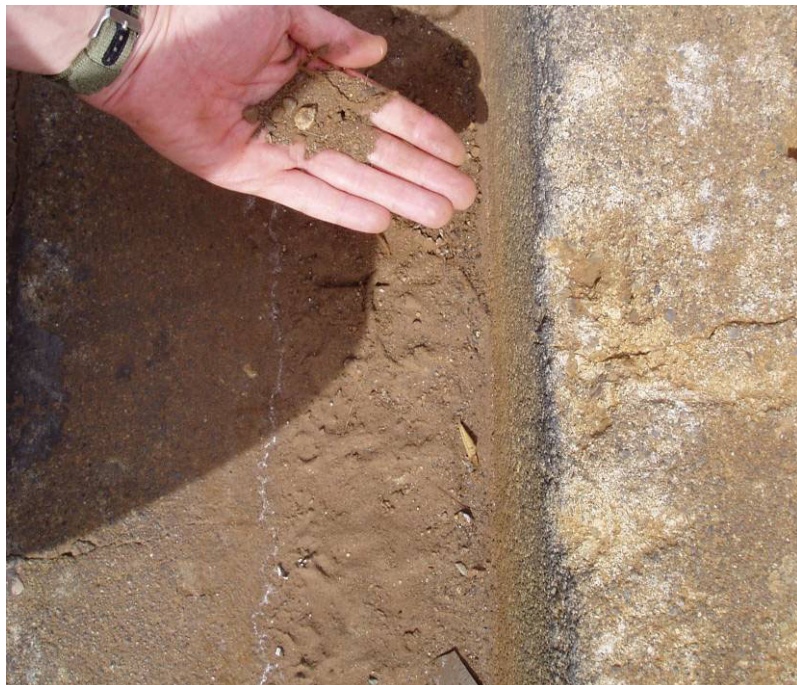
**Photo 2      Metallic Debris Accumulated in roadside in East Street (04/11/04)**

Following collection of the stormwater sample on 4 November 2004, an accumulation of rusty sediment was also noted in the East Street kerb and channel to the rear of the Exide Technologies slag reprocessing area (see Photo 2). A single sample was obtained by pushing a plastic sample container into the accumulated sediment.

The roadside sediment sample collected from the kerb and channel exhibited elevated concentrations for a range of heavy metals. In particular, lead in the sediment exceeded guideline values by 195 times, while both arsenic and antimony exceeded guideline values by a factor of approximately 20.

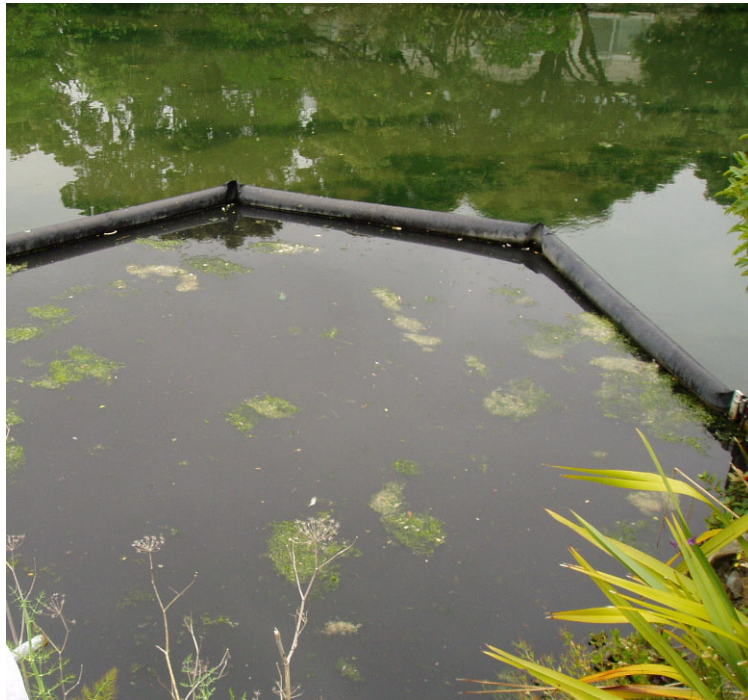
**Photo 6 Impact on Te Mome Stream from Exide Technologies Incident (15/12/05)**

The incident of 14 December 2004 confirmed that contaminants entering stormwater drains in East Street to the rear of the Exide Technologies site can discharge into the Te Mome Stream via an outfall in the vicinity of Unilever Australasia Limited. It is therefore possible that contaminated street sediment and stormwater in East Street can also enter the Te Mome Stream. Following this incident, Greater Wellington Regional Council issued Exide Technologies with an abatement notice, restricting further release of acid or heavy metal contaminants to the stormwater system. Exide Technologies also committed to undertake an independent investigation into possible contaminant contributions from its site to the Te Mome Stream.

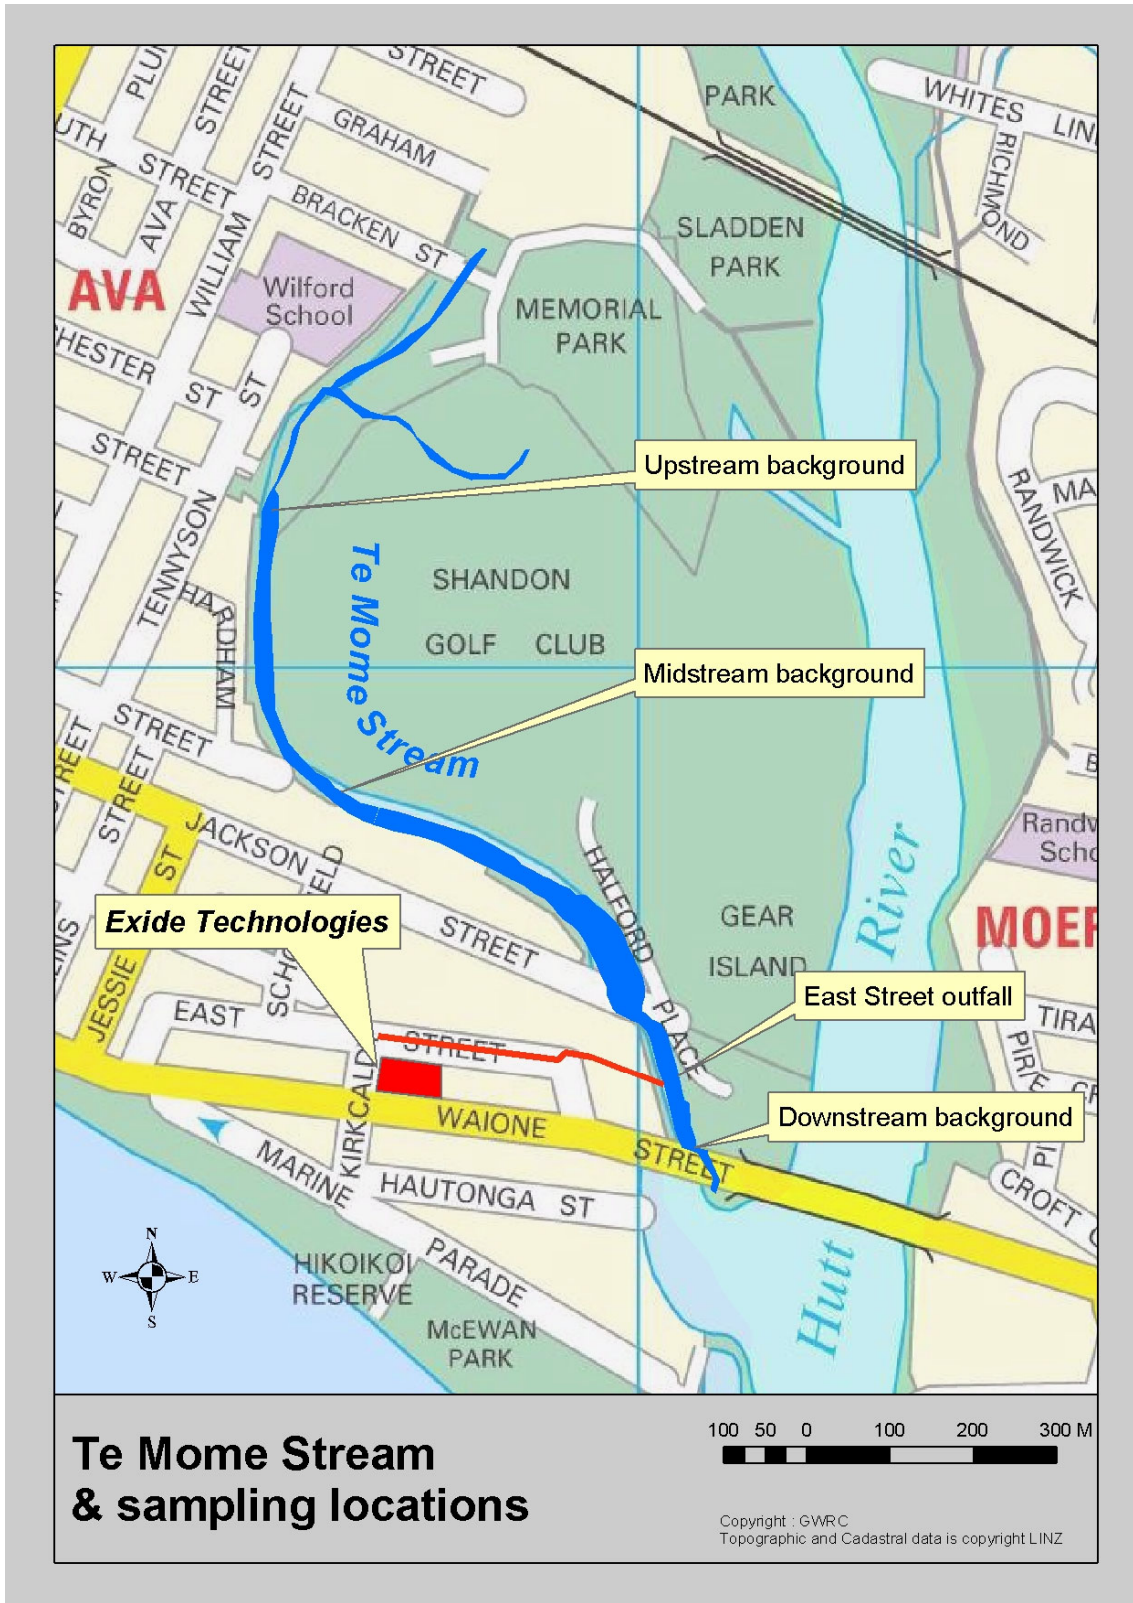
Figure 1 Te Mome Stream & Surroundings

The Te Mome Stream is a tidally influenced ‘dead arm’ of the Hutt River, which runs for 1.4km alongside the suburb of Ava near Lower Hutt (see Figure 1). The stream is up to 40 metres wide and 1.5 metres deep, with a tidal range of around 0.5 metres, that exposes fringing sediments at low tide. Stream sediments are highly organic, and in excess of 0.5 metres deep in places, ranging from silt to sandy mud. Stream biodiversity is limited, with the predominant biota being eels, algae and reeds.

Following the incident of 15 December 2004, grab samples of water (5) and sediment (15) were taken from the Te Mome Stream on 24 December 2004, at locations indicated in Figure 1. Samples were analysed for heavy metal contamination. Lead and antimony which are understood to be the ‘signature’ contaminants of the lead-acid battery recycling process used by Exide Technologies<sup>2</sup>.

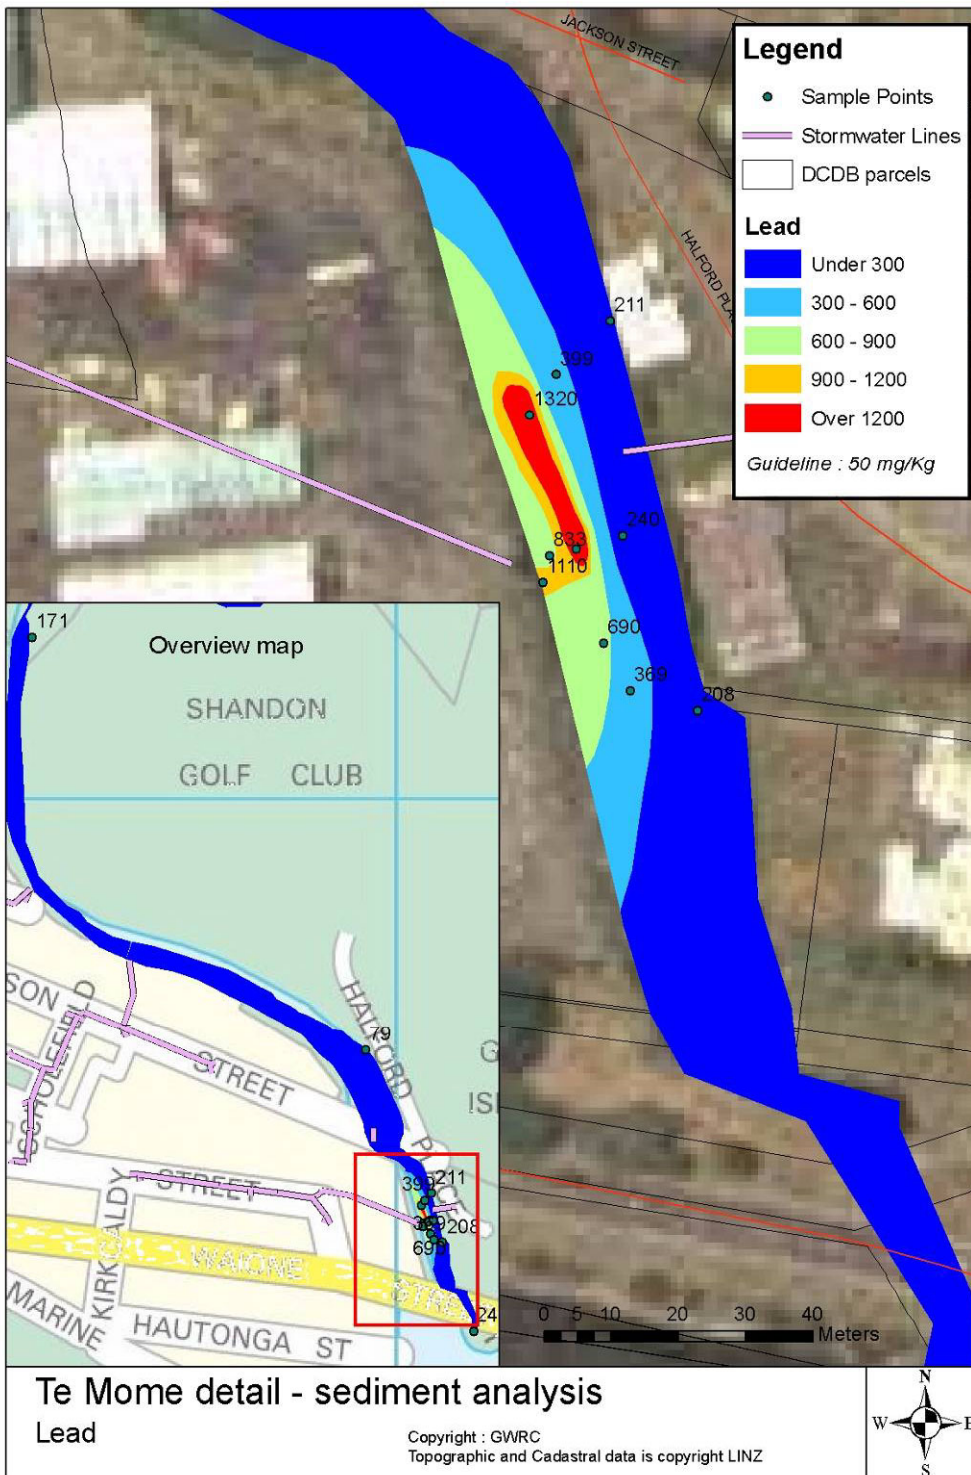
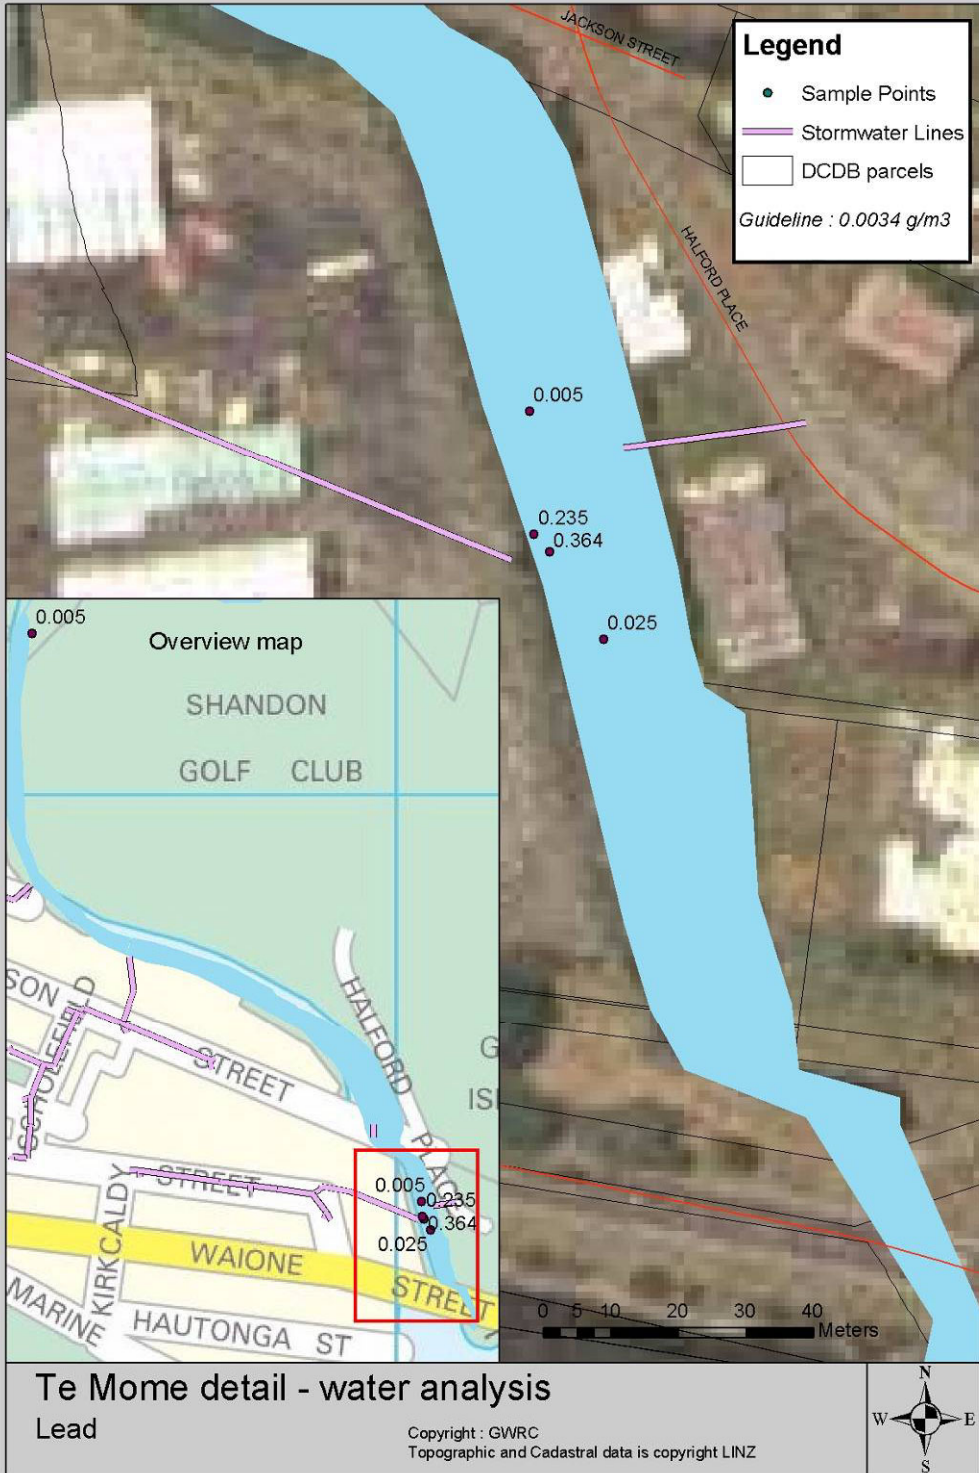
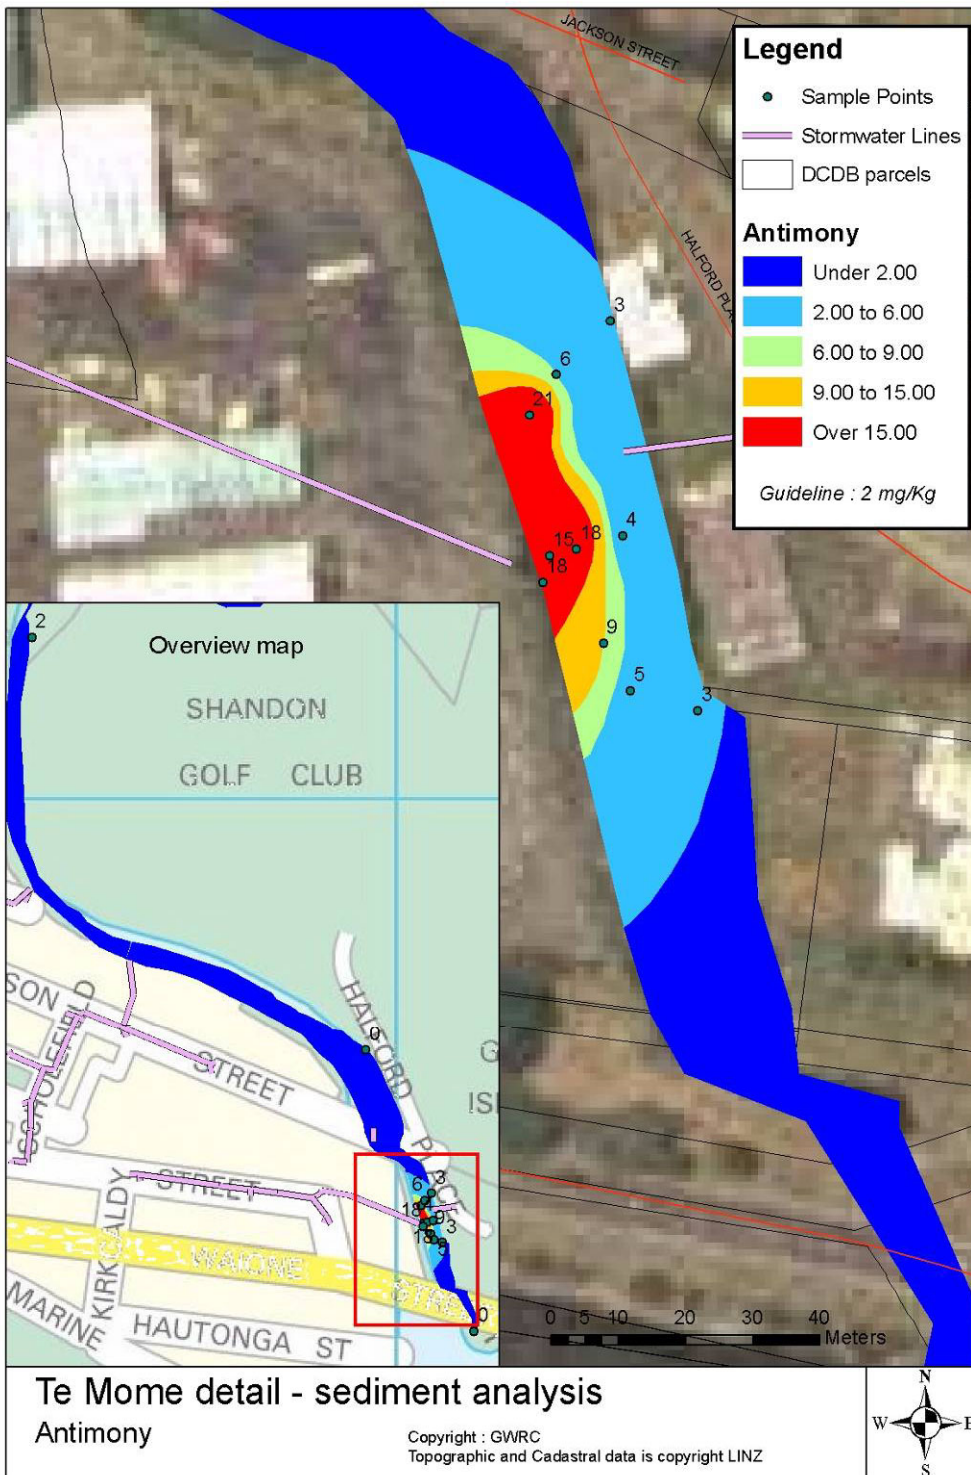
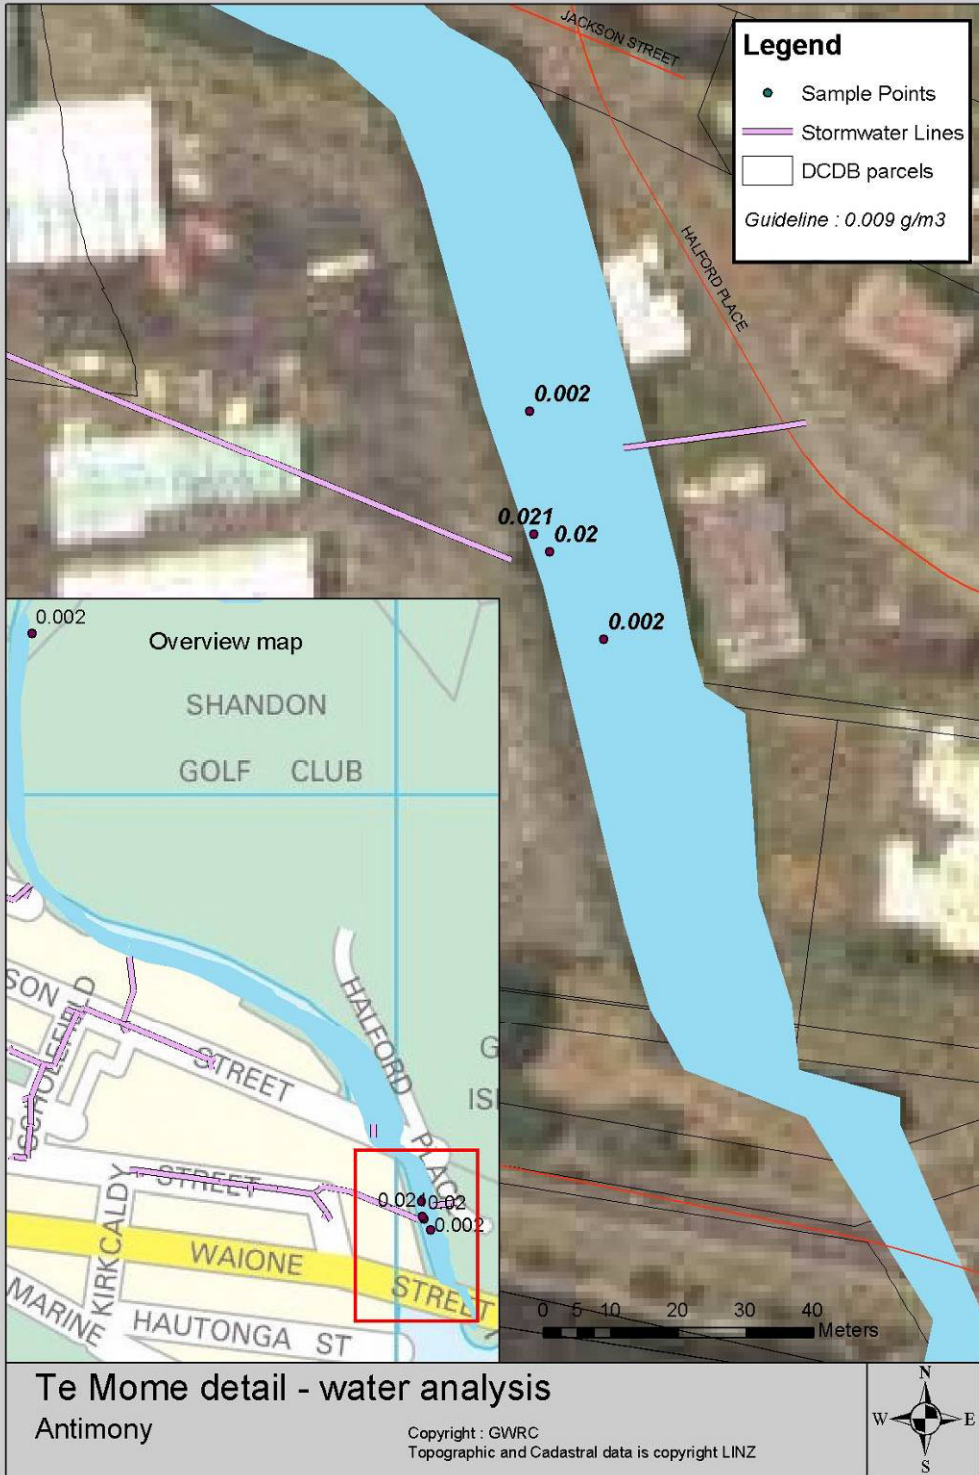
The following figures illustrate sample results for the following:

- a) Lead concentrations in Te Mome Stream sediments
- b) Lead concentrations in Te Mome Stream water
- c) Antimony concentrations in Te Mome Stream sediments
- d) Antimony concentrations in Te Mome Stream water
