Castlepoint Beach

Fine Scale Monitoring 2008/09

Prepared
for
**Greater
Wellington
Regional
Council**
May
2009

Barry Robertson and Leigh Stevens

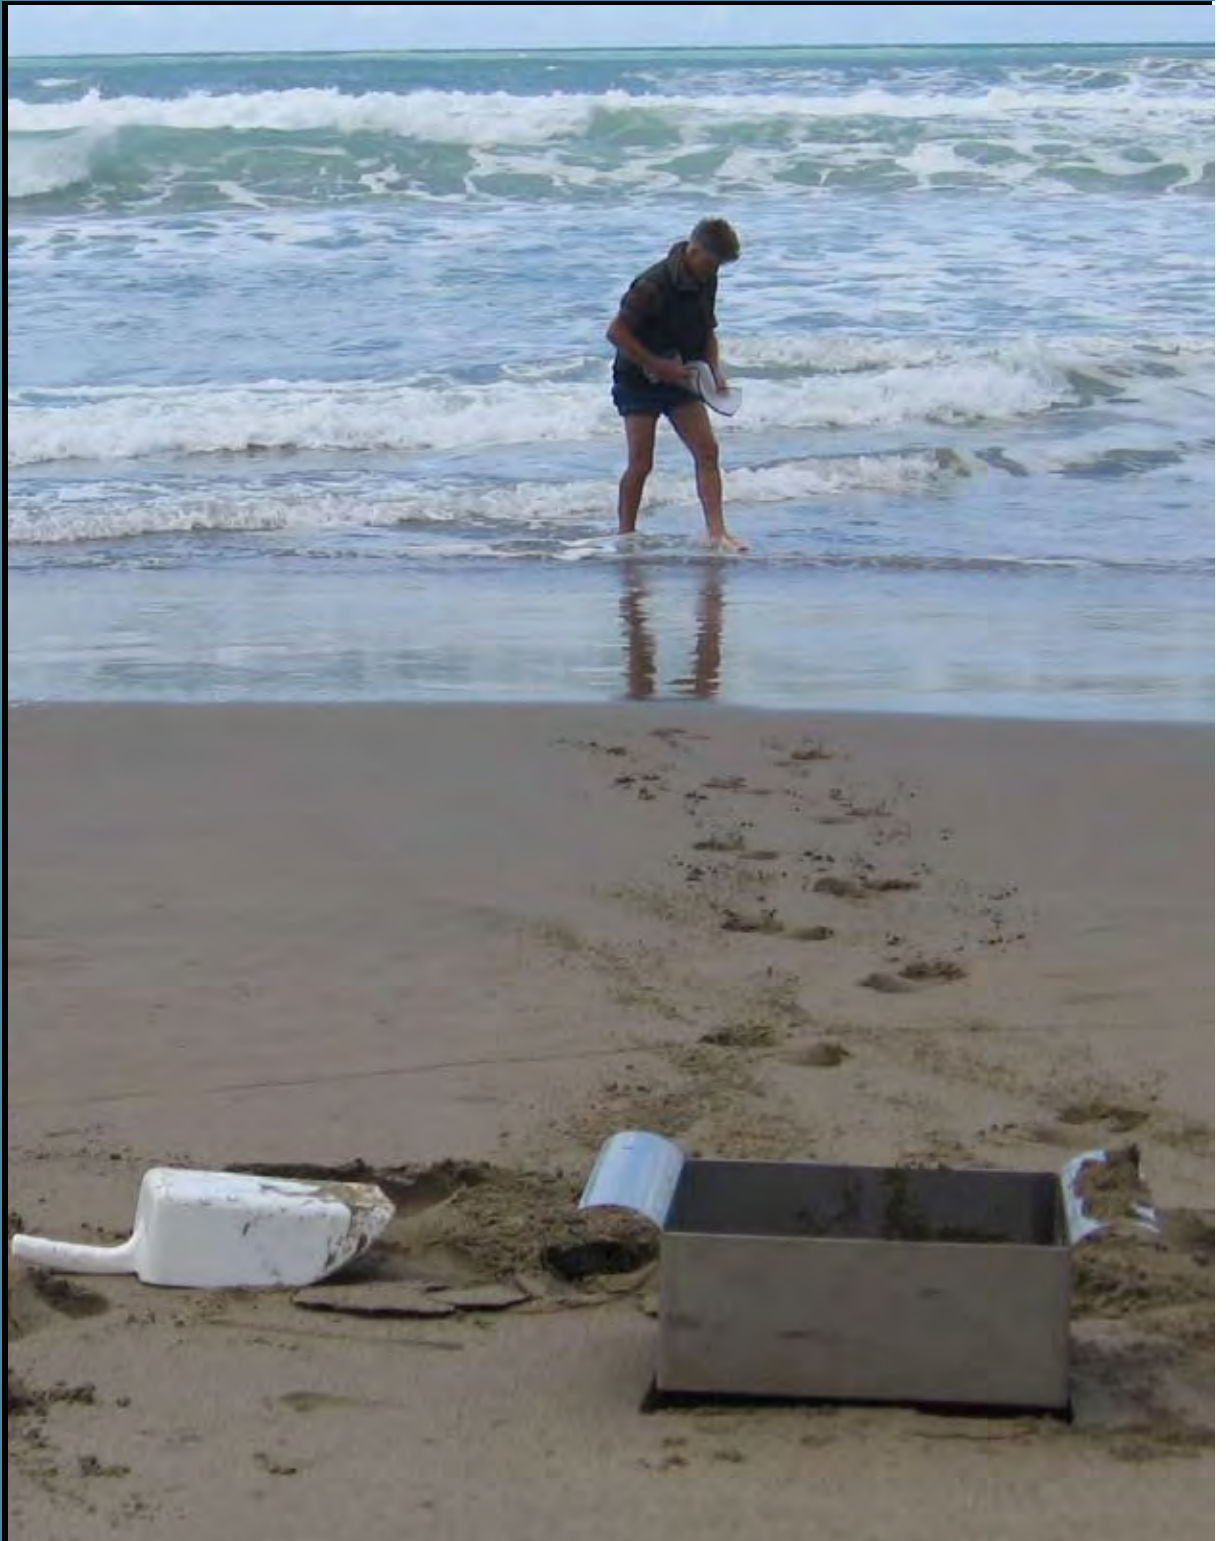
Cover Photo: Castlepoint Beach Fine Scale Monitoring 2009 - Dr Barry Robertson sieving sand from sediment core bags.

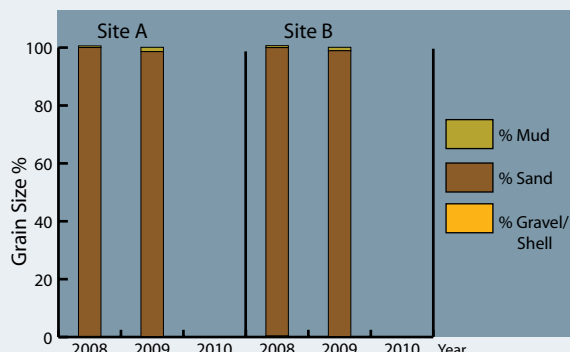
Figure 5 Grain size at Castlepoint Beach (mean values at each transect).

Soil erosion is a major issue in New Zealand and the resulting suspended sediment impacts are of particular concern in many coastal areas. The northern Wairarapa coastal environments are especially at risk in that the erosion ratings for inland catchments feeding the coast are moderate to severe. As a consequence, the waters bathing the coastal areas tend to have a high suspended solids content. Deposition of these solids tends to be offshore, or in sheltered embayments, beaches or estuaries. Castlepoint, being an exposed beach is not expected to be at risk from excessive sedimentation of fine sediments. This was confirmed by the 2008 and 2009 grain size monitoring results which show that all sites were dominated by sandy sediments (> 99% sand) (Figure 5). Interestingly, however, the 2009 results indicated a 1% increase in the mud content at most sites, and a decrease in the gravel/shell component showing that the beach system is temporally variable.
