Waikanae River Estuary

Intertidal Macroalgal Monitoring 2009/10

Prepared
for
**Greater
Wellington
Regional
Council**
May
2010

Leigh Stevens and Barry Robertson

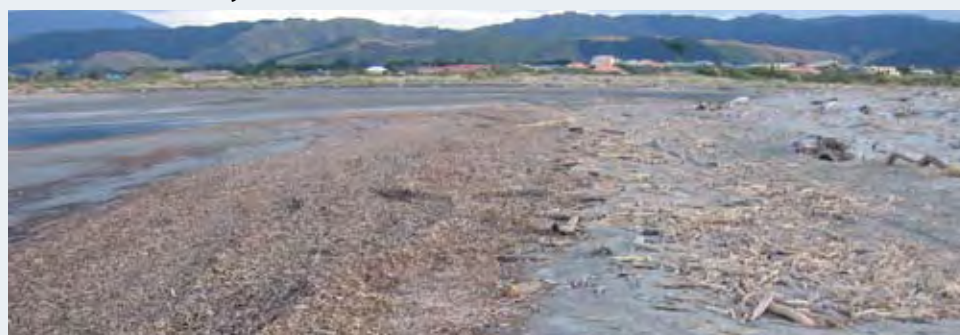
One notable feature of the lower estuary where it flows behind the frontal dune on the beach is the extensive accumulations of driftwood and organic material along the high tide line (Figure 2). These accumulations appear to be frequently moved by the tide and consequently do not appear to be causing problems such as anoxic or sulphide rich sediments.

Figure 2. Driftwood and organic material accumulating along the high tide line in the lower estuary.
