Is it safe to swim?

Recreational water quality monitoring
results for the 2015/16 summer

Morar SR and Greenfield S. 2016. Is it safe to swim? Recreational water quality monitoring results for the 2015/16 summer. Greater Wellington Regional Council, Publication No. GW/ESCI-T-16/33, Wellington.

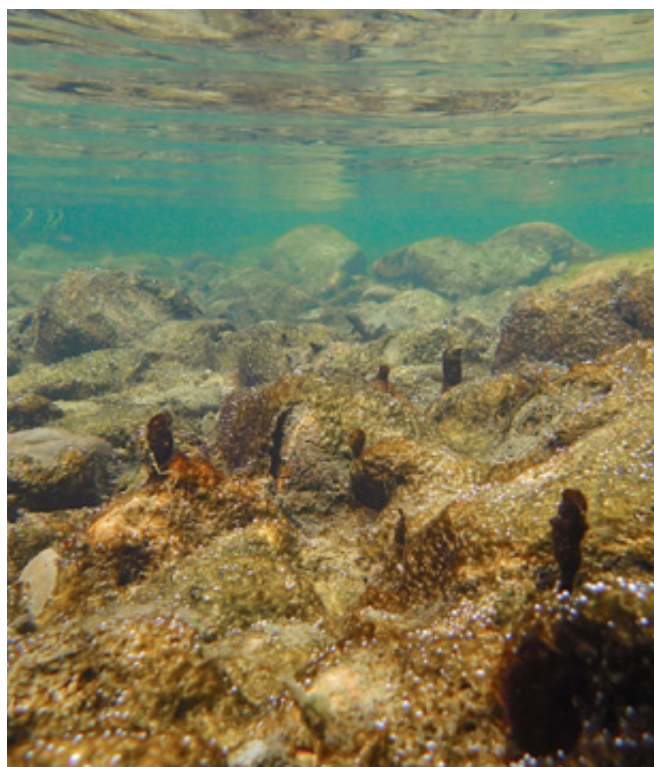
Cyanobacteria mats growing on the river bed at Pakuratahi River at Kaitoke Regional Park on 15 February 2016

- A site in the lower reaches of the Pakuratahi River as it runs through Kaitoke Regional Park exceeded the action level on 16 February. Warning signs were put up by GWRC along this part of the river. The site (Pakuratahi River 50m downstream of Farm Creek) is not part of the Recreational Water Quality monitoring programme but is assessed monthly as part of the Rivers State of the Environment programme. The site also exceeded the alert level between 8 March and the end of the bathing season.
- All guideline exceedances were reported at www.gw.govt.nz/summer-check and www.gw.govt.nz/is-it-safe-to-swim/. These webpages were advertised on radio and noted on toxic algae information signs as providing up-to-date toxic algae warning information. Warnings were also posted on the Land Air Water Aotearoa (LAWA) website www.lawa.org.nz.
