# Masterton Wastewater Upgrade: Groundwater Report

Prepared for  
Beca Carter Hollings & Ferner Limited

December 2006

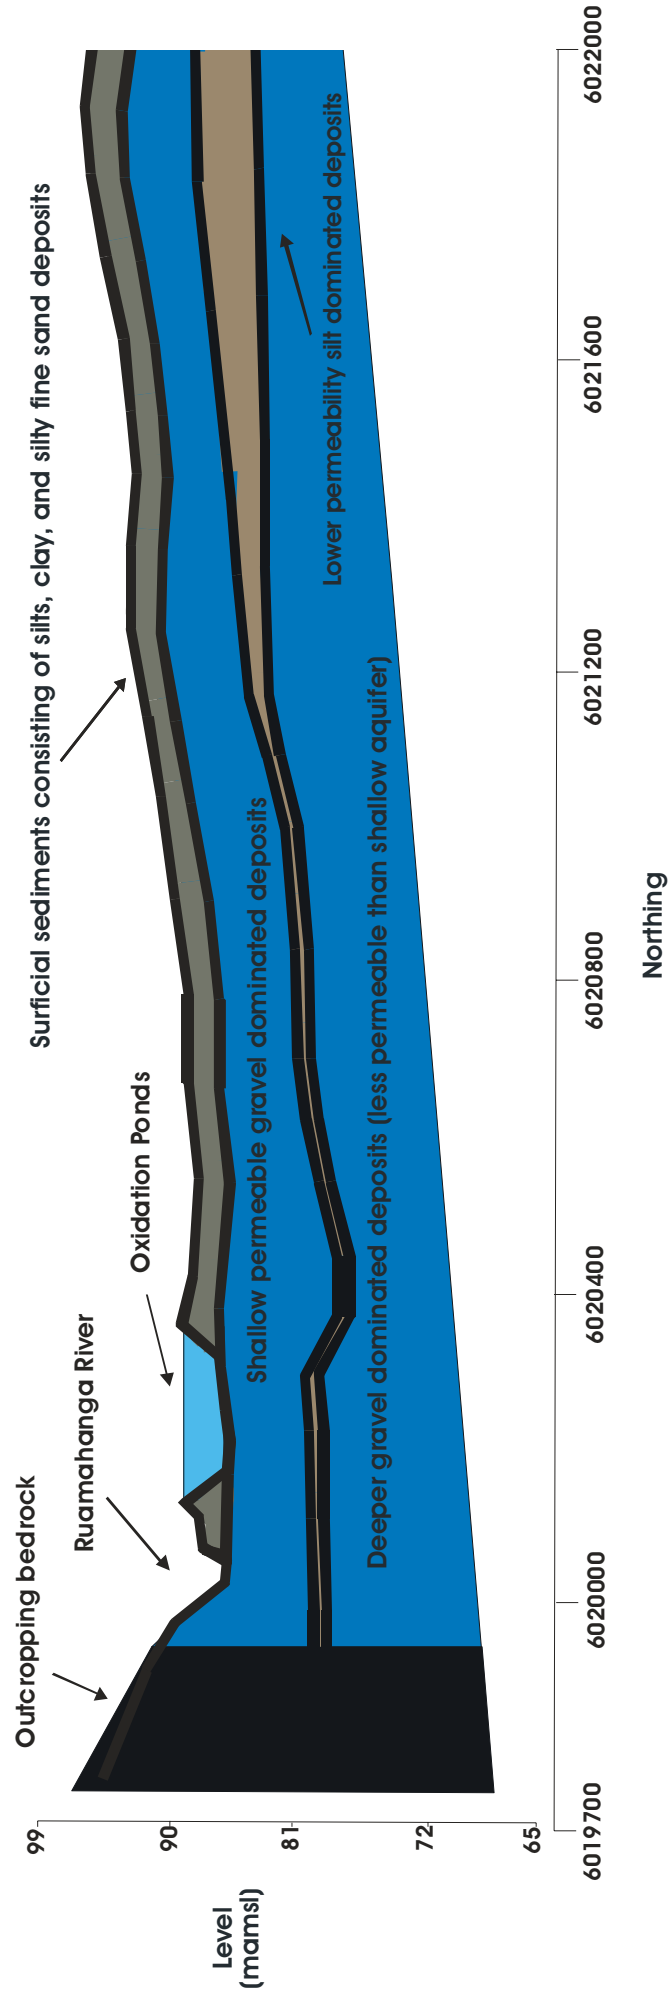
Figure 4: Geological Cross-section - A-A'

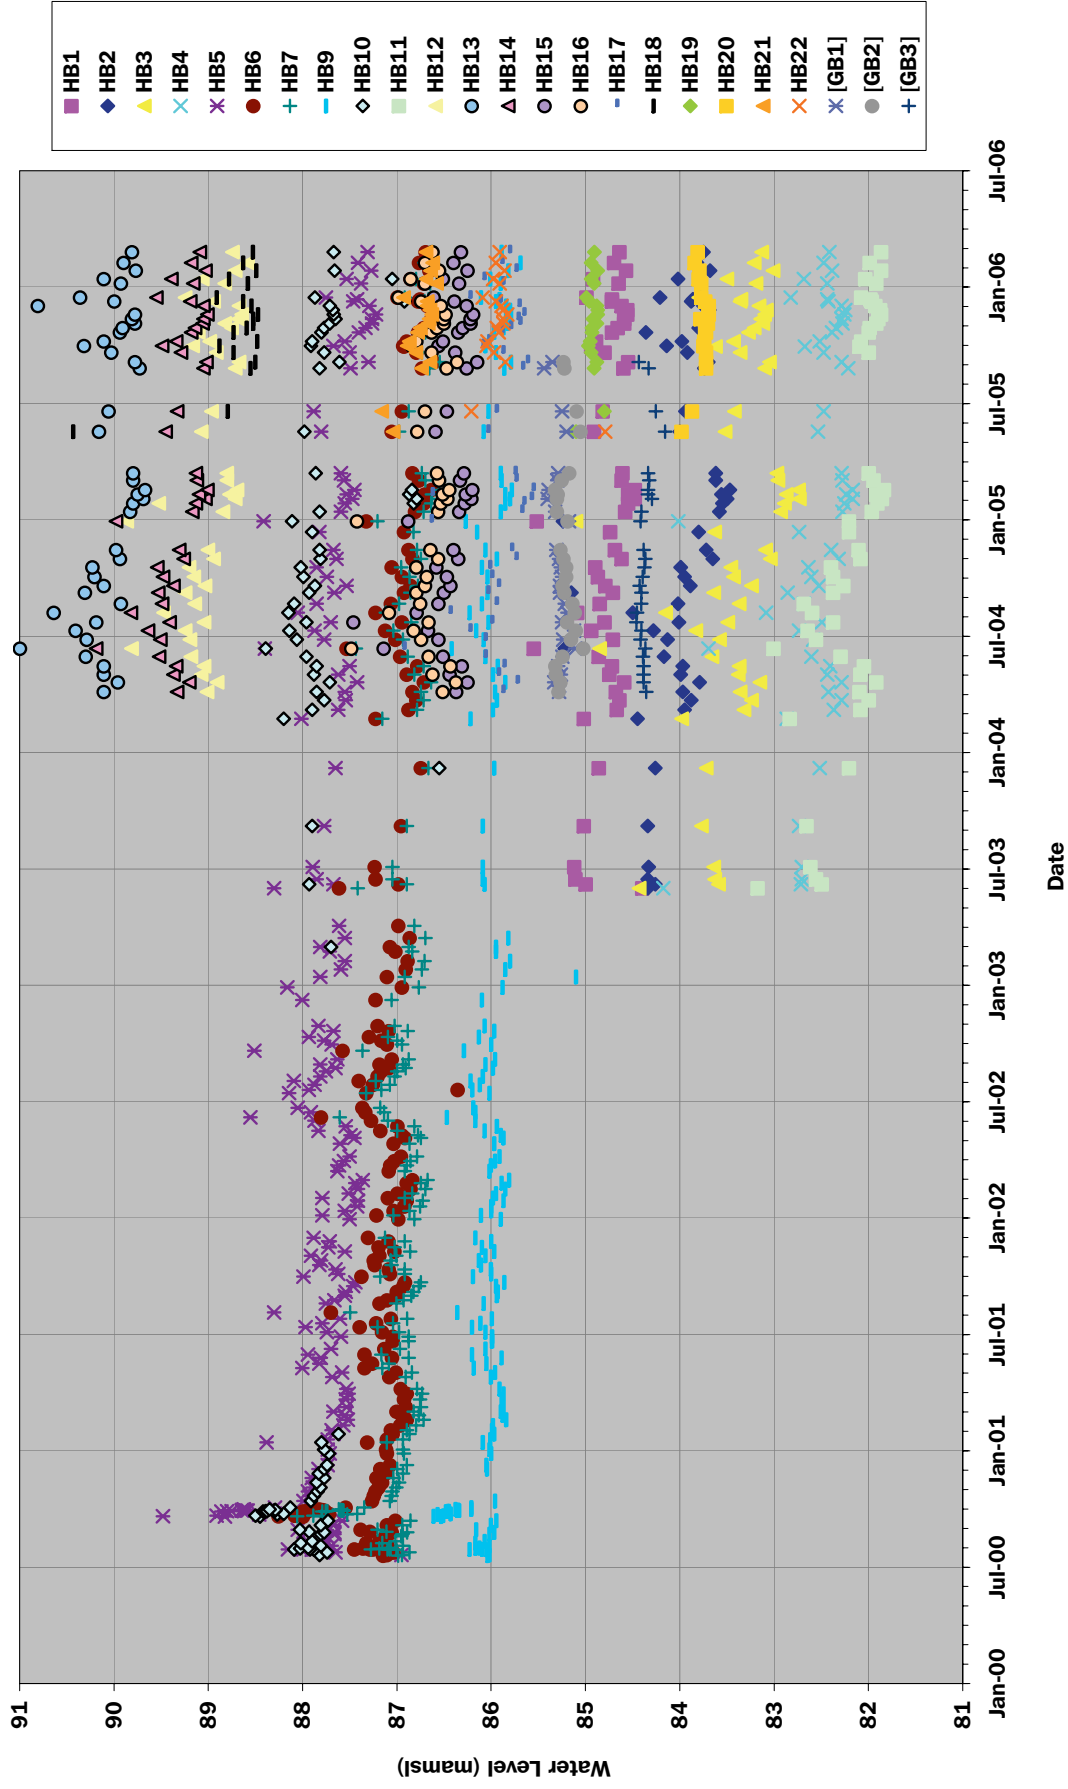
**Figure 7: Long-term groundwater monitoring records (3 surface water gauging sites on the Makoura Stream are also included)**

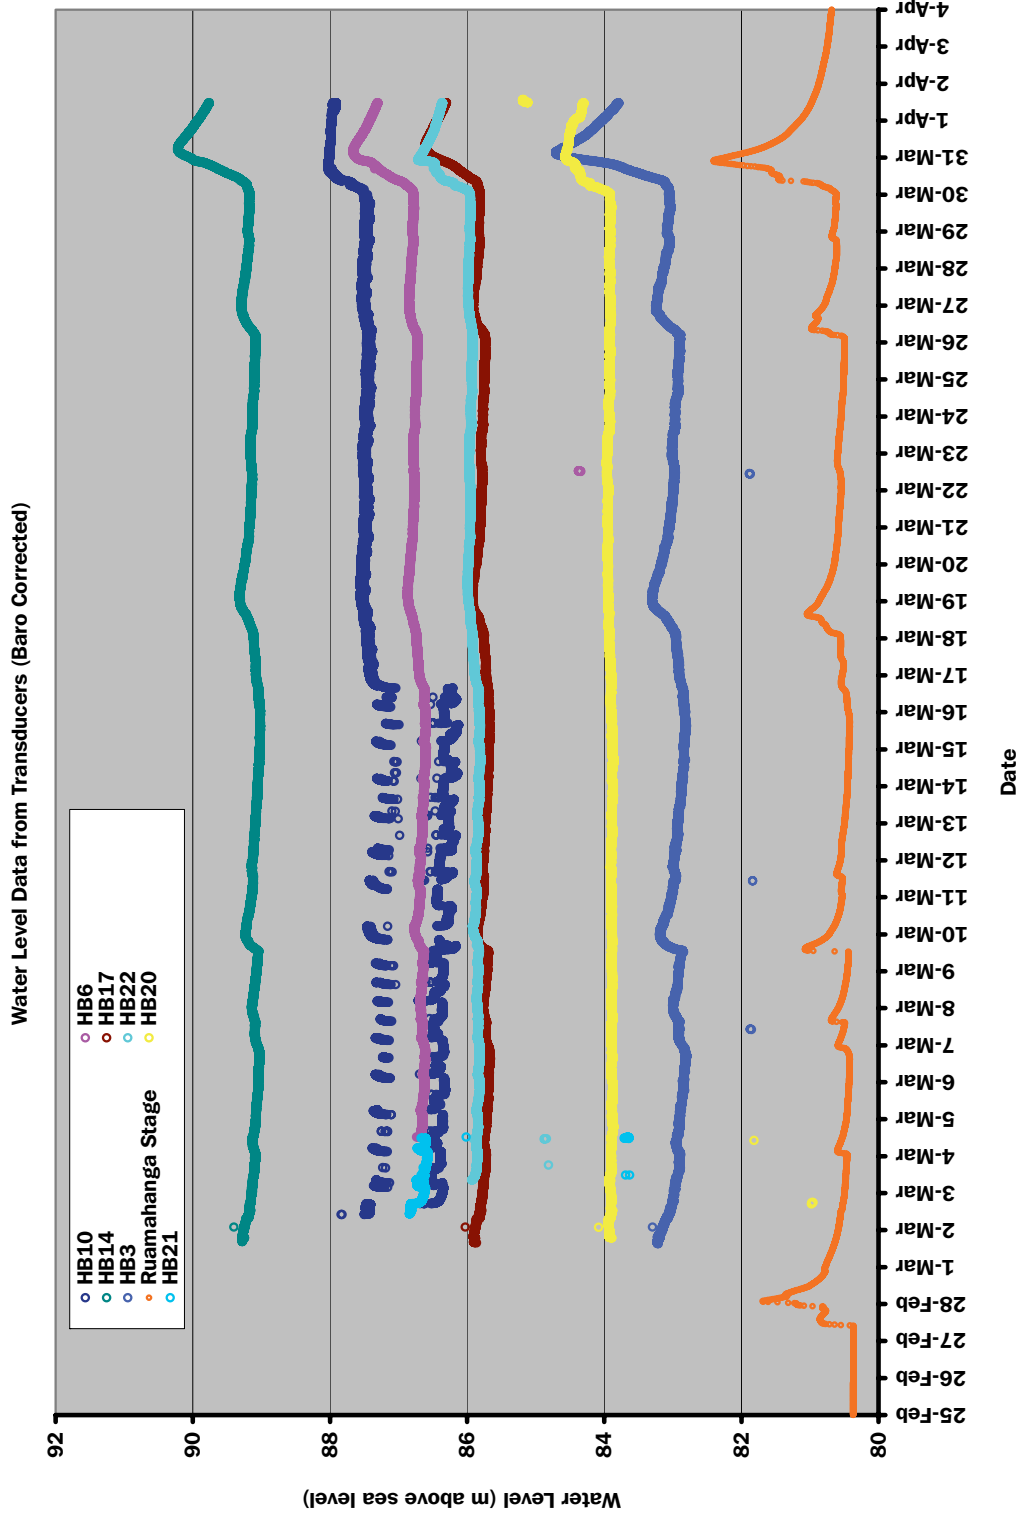
**Figure 8: Groundwater levels in 8 wells across the site and Ruamahanga River Stage at Wardells Bridge recorded over February-April 2005**

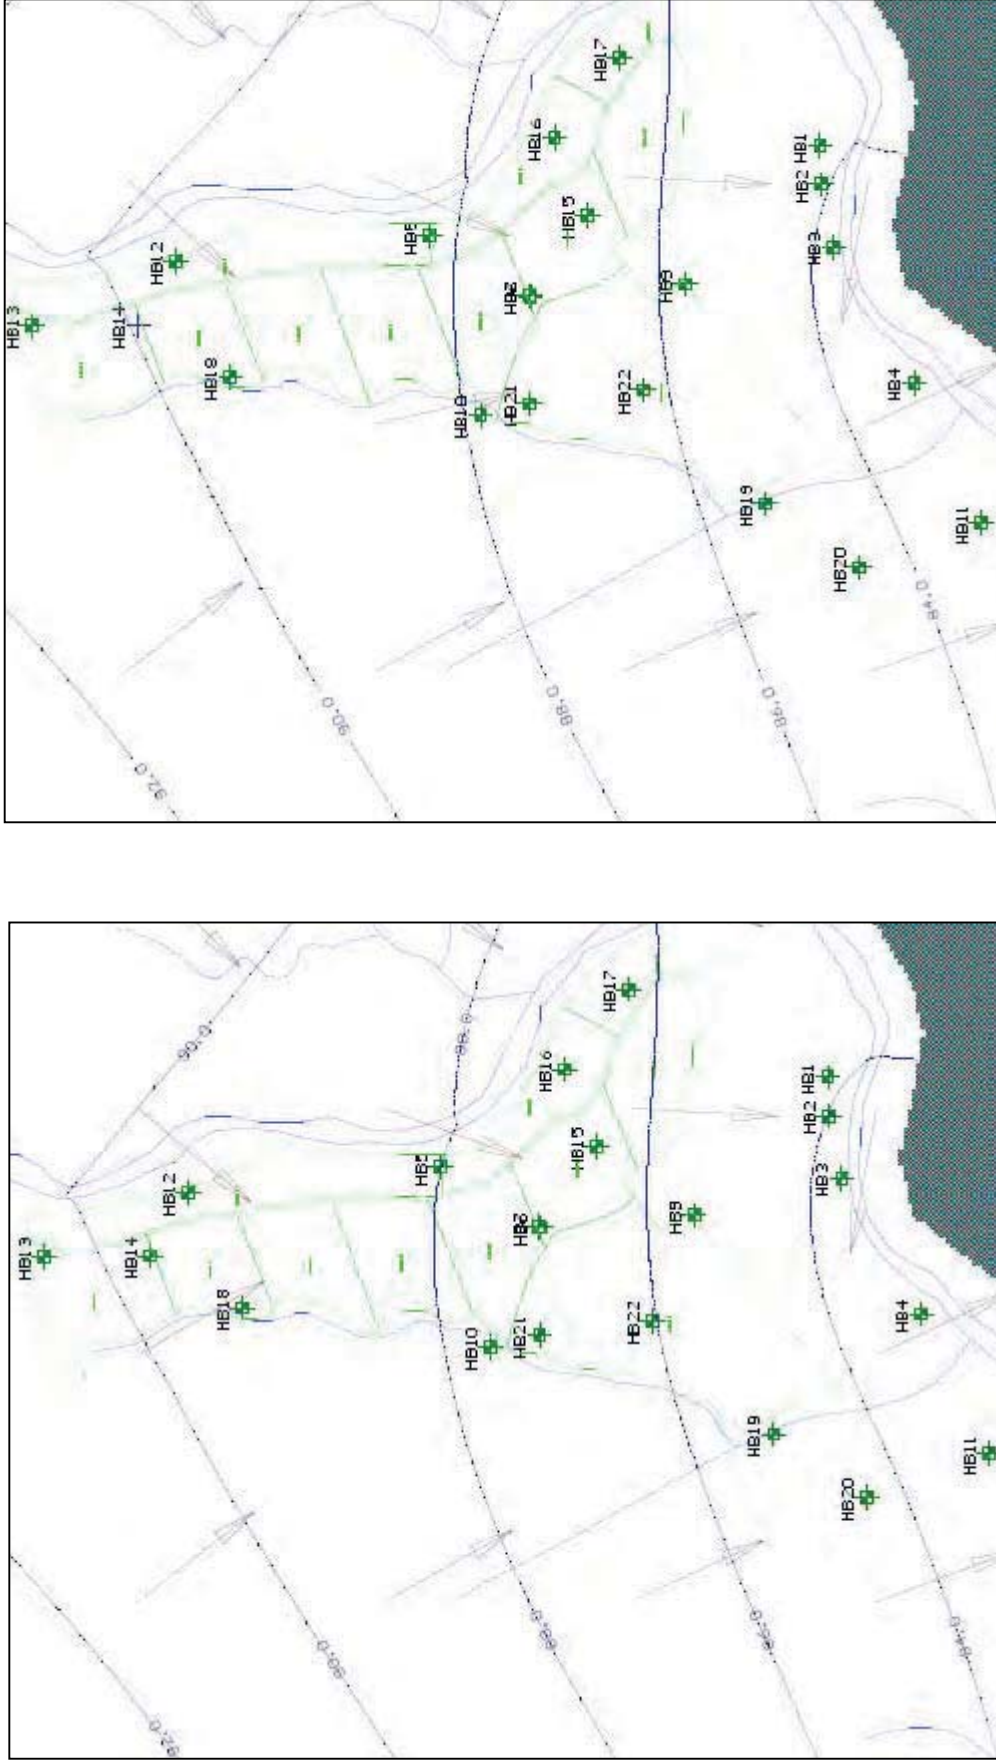
**Figure 12: Modelled piezometric contours. The pre and post irrigation contours are shown in the left and right figures respectively.**

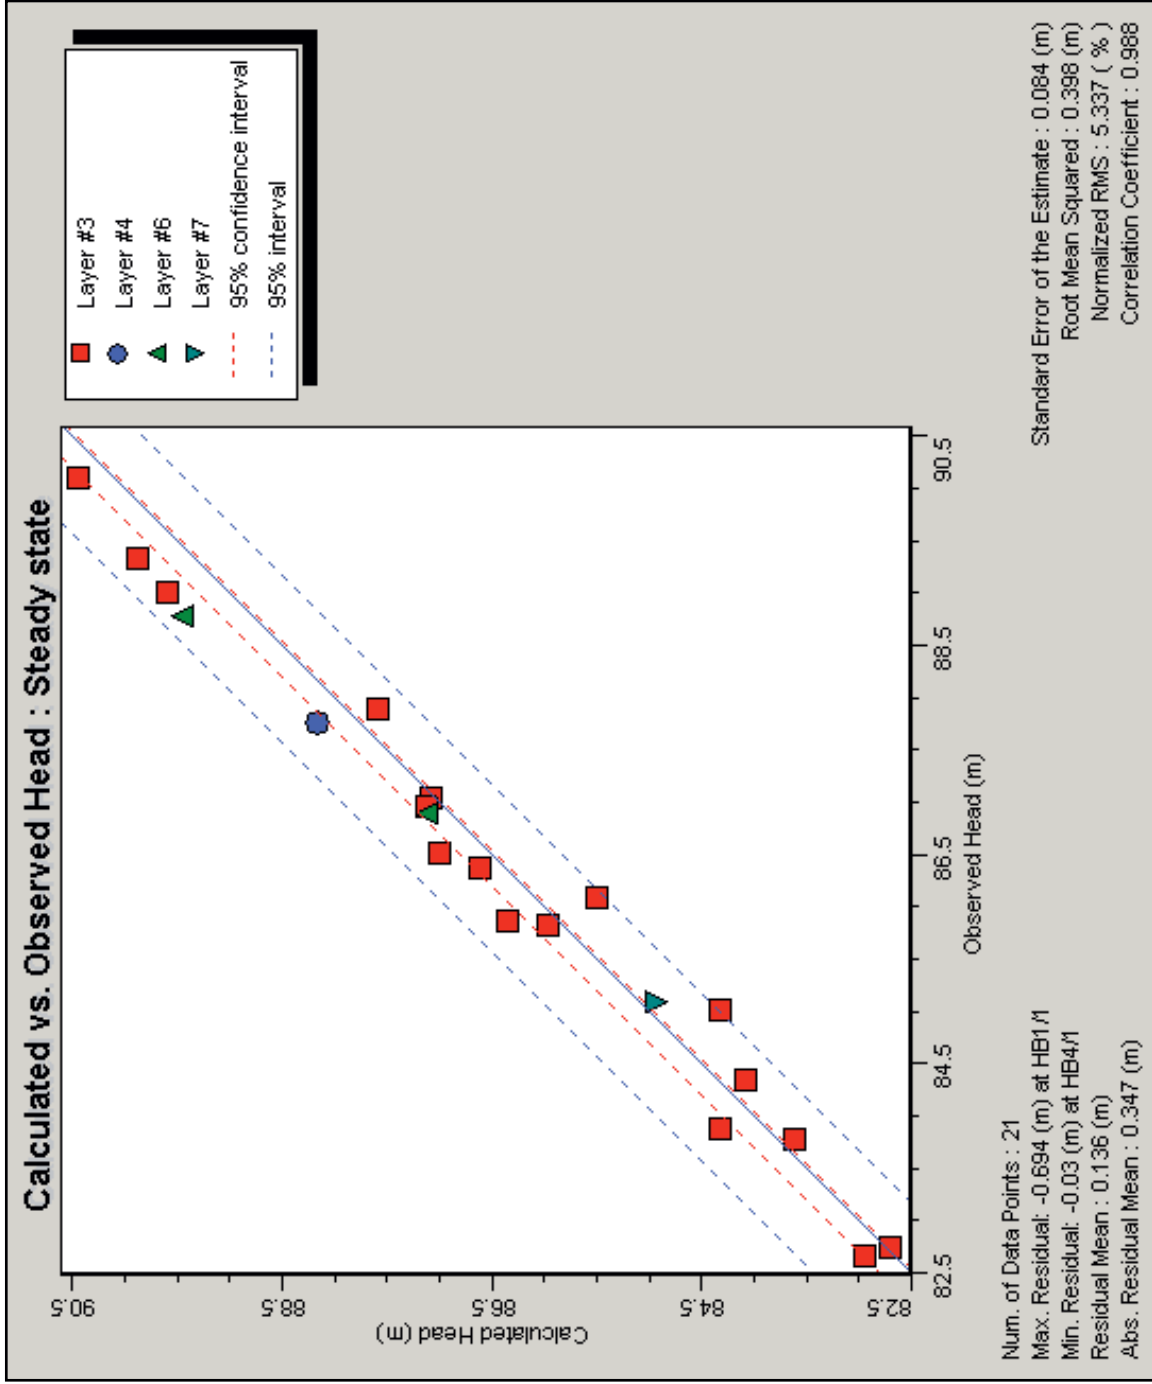
**Figure 13: Plot illustrating degree of model calibration for the pre-irrigation steady state run**

A plot of simulated versus measured heads is shown in Figure 13 for the 21 wells used for steady state calibration. This plot provides a guide as to the degree of calibration of the simulations; the closer the simulated heads are to the observed heads the better the calibration. The relative difference between the simulated groundwater levels and the measured groundwater levels (the residual errors) are shown in Figure 14 in the form of a histogram. Figure 14 shows the residuals tend to be positive, meaning that the modelled heads are slightly higher than observed heads. The source of the disparity is likely explained by the uncertainties in our knowledge of groundwater discharge to the surface waterways, recharge from the rivers, effective rainfall recharge and regional and depth variation in aquifer hydraulic conductivity. Any mathematical modelling exercise such as the one in this report has to be viewed in light of these uncertainties.

model with a normalised root mean squared error less than 10% to be a calibrated model. This means that the discrepancies between the simulated and observed heads are small, and the model is therefore well calibrated and provides a good representation of the groundwater flow system.

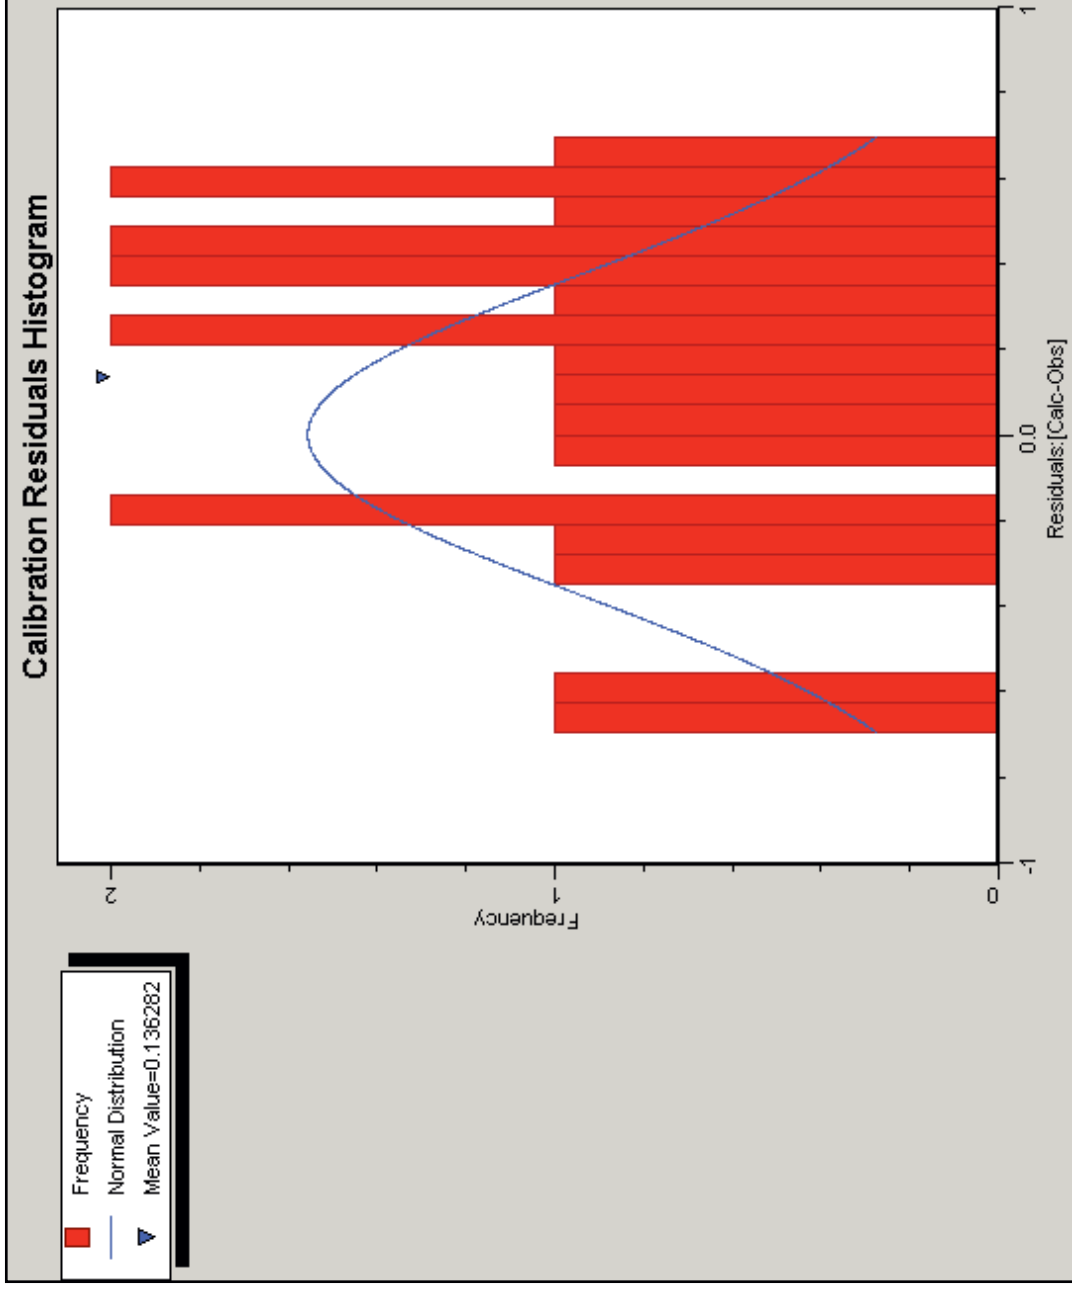
**Figure 14: Histogram that illustrates that the modelled heads are slightly higher than the measured heads for the pre-irrigation steady state**

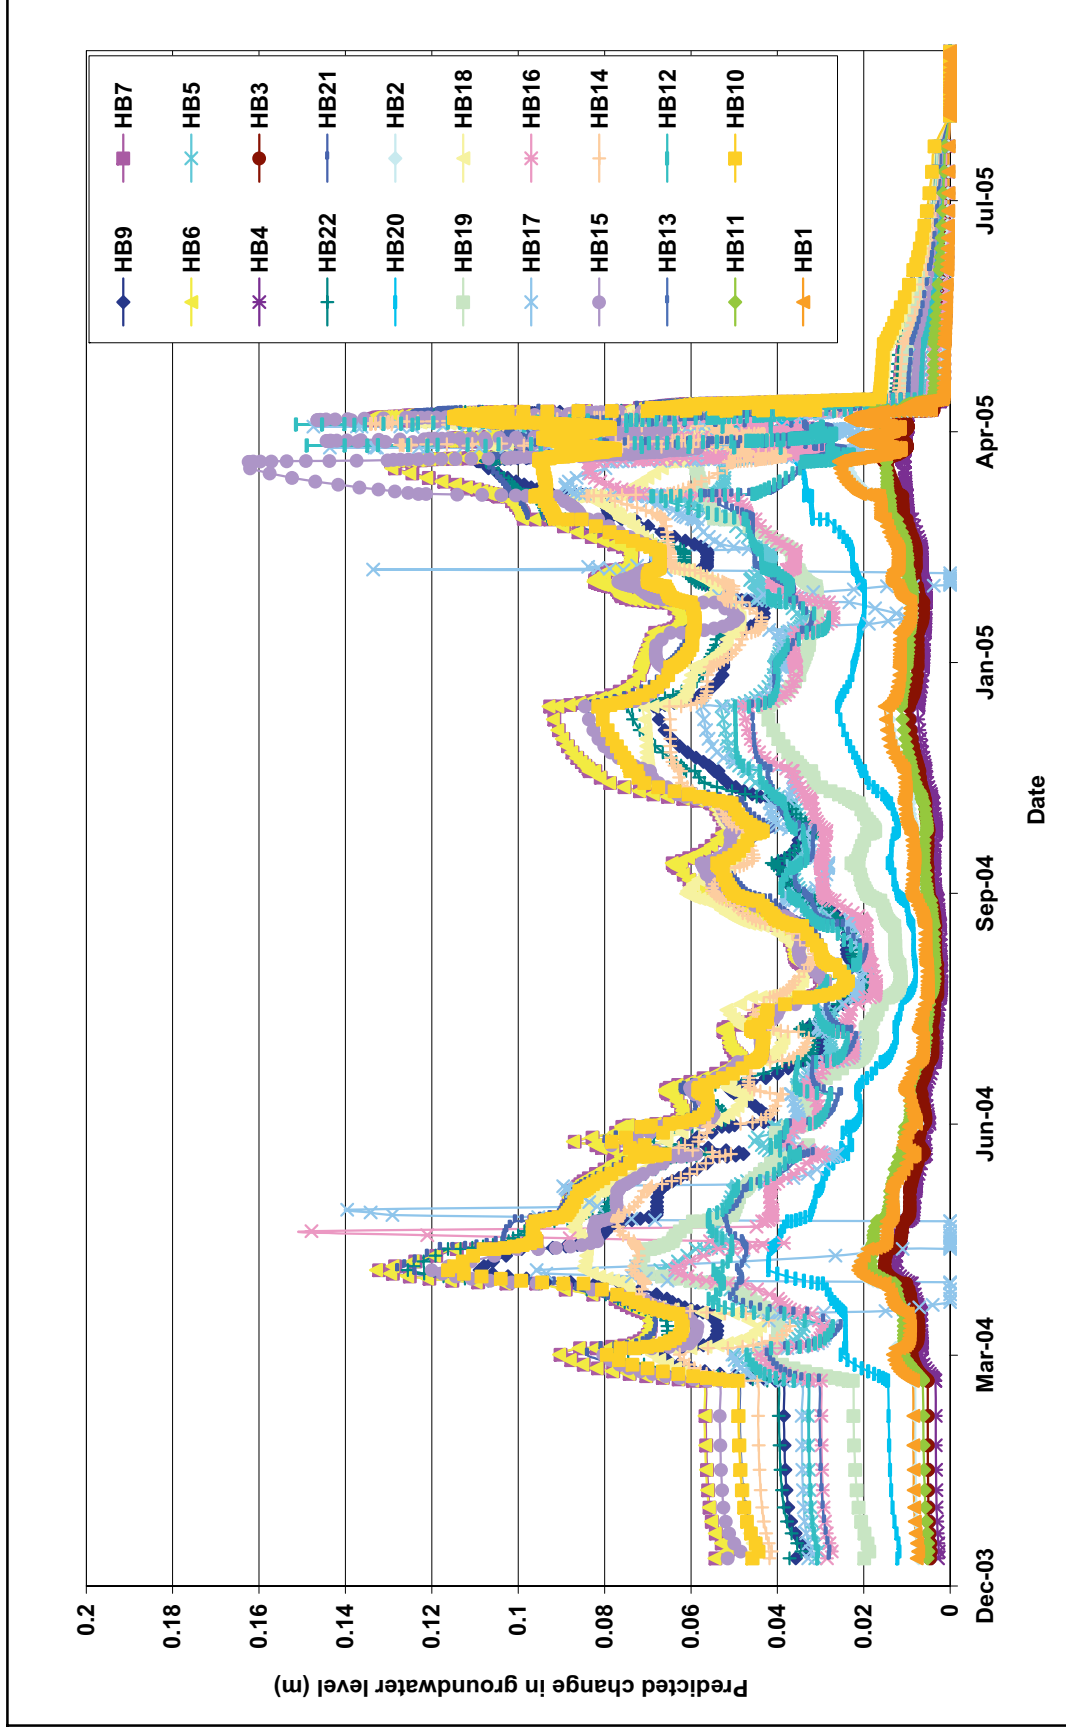
Figure 15: Simulated changes in groundwater levels for irrigation Option 6

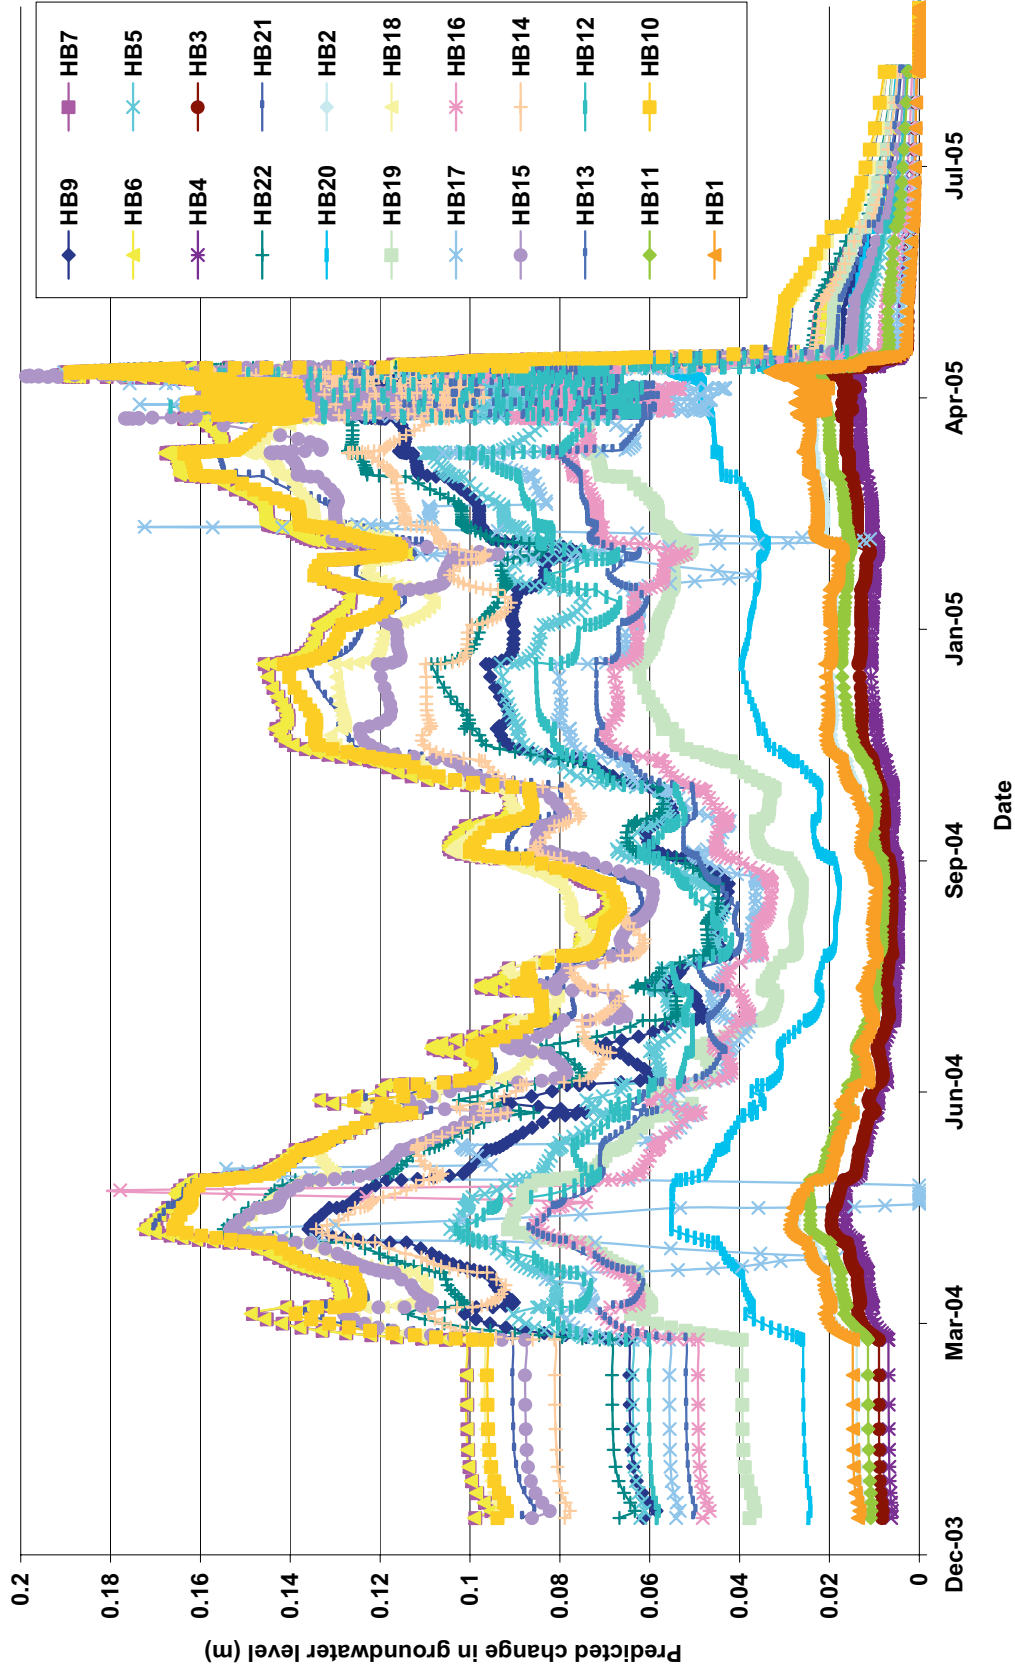
Figure 16: Simulated changes in groundwater levels for irrigation Option 3

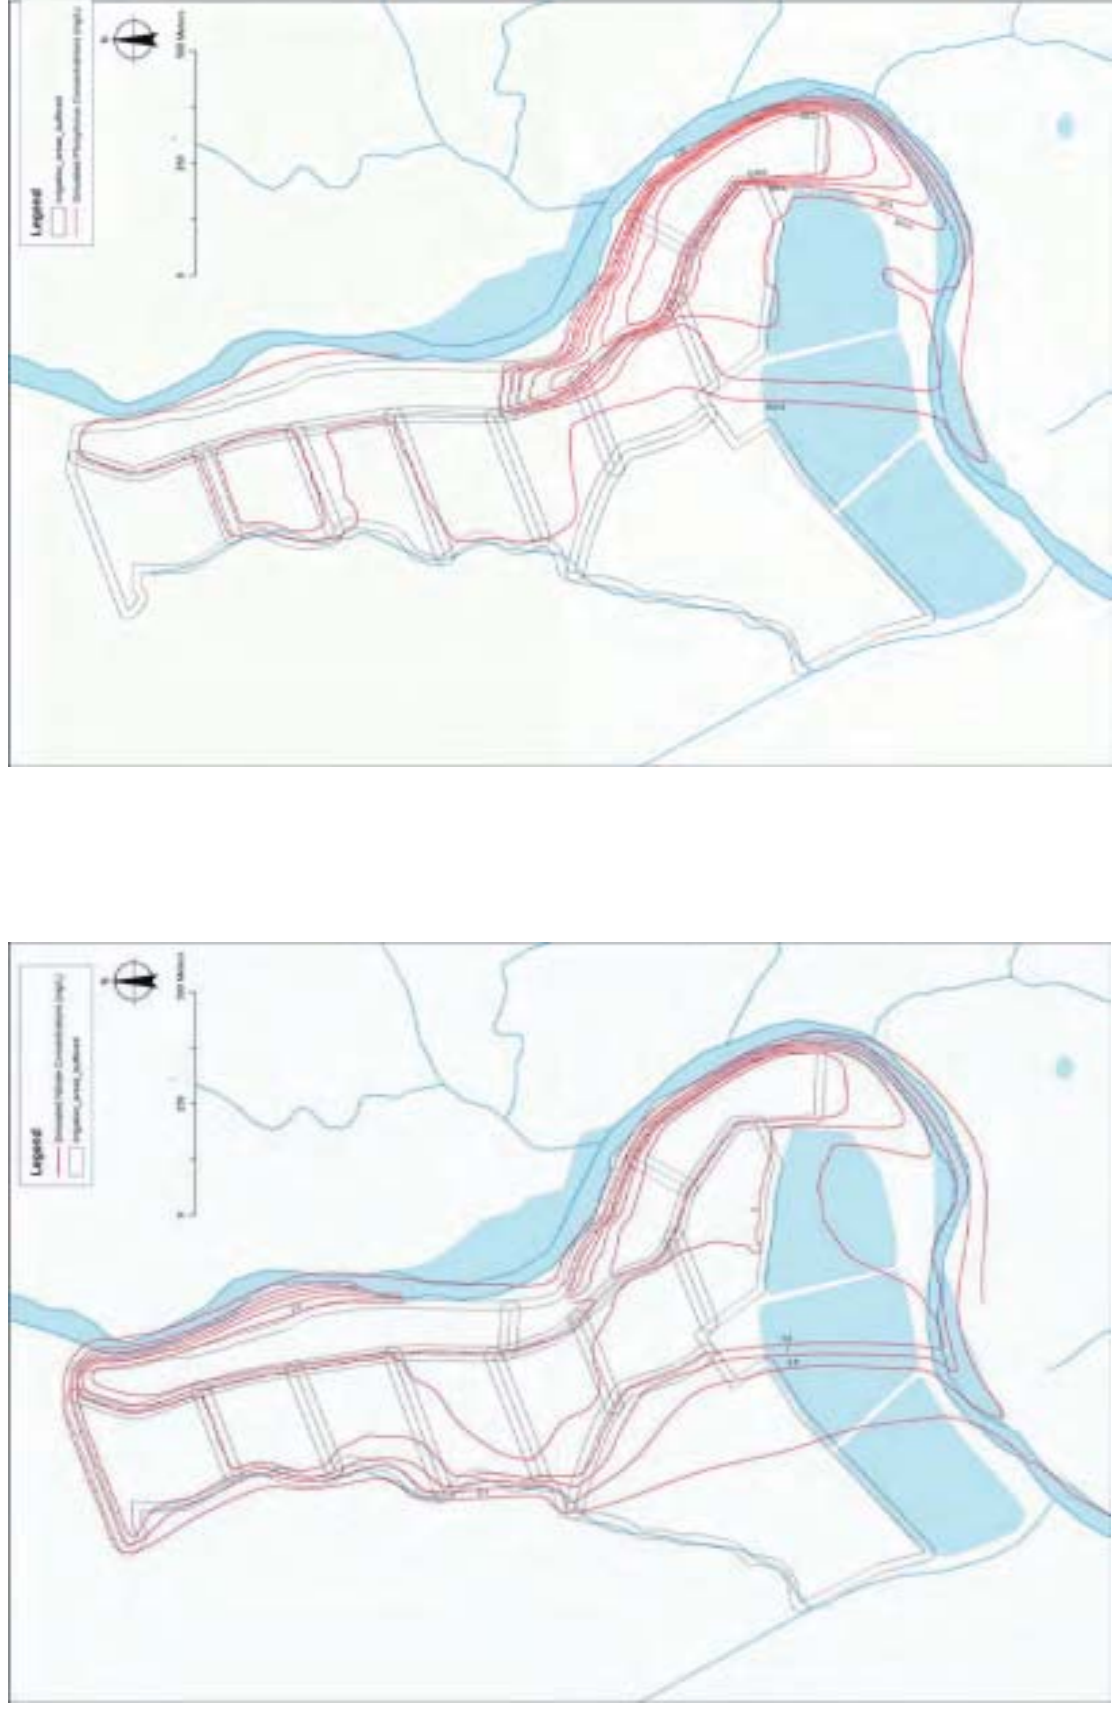
Figure 17: Plots of modelled nitrate and phosphorous concentrations for Option 6

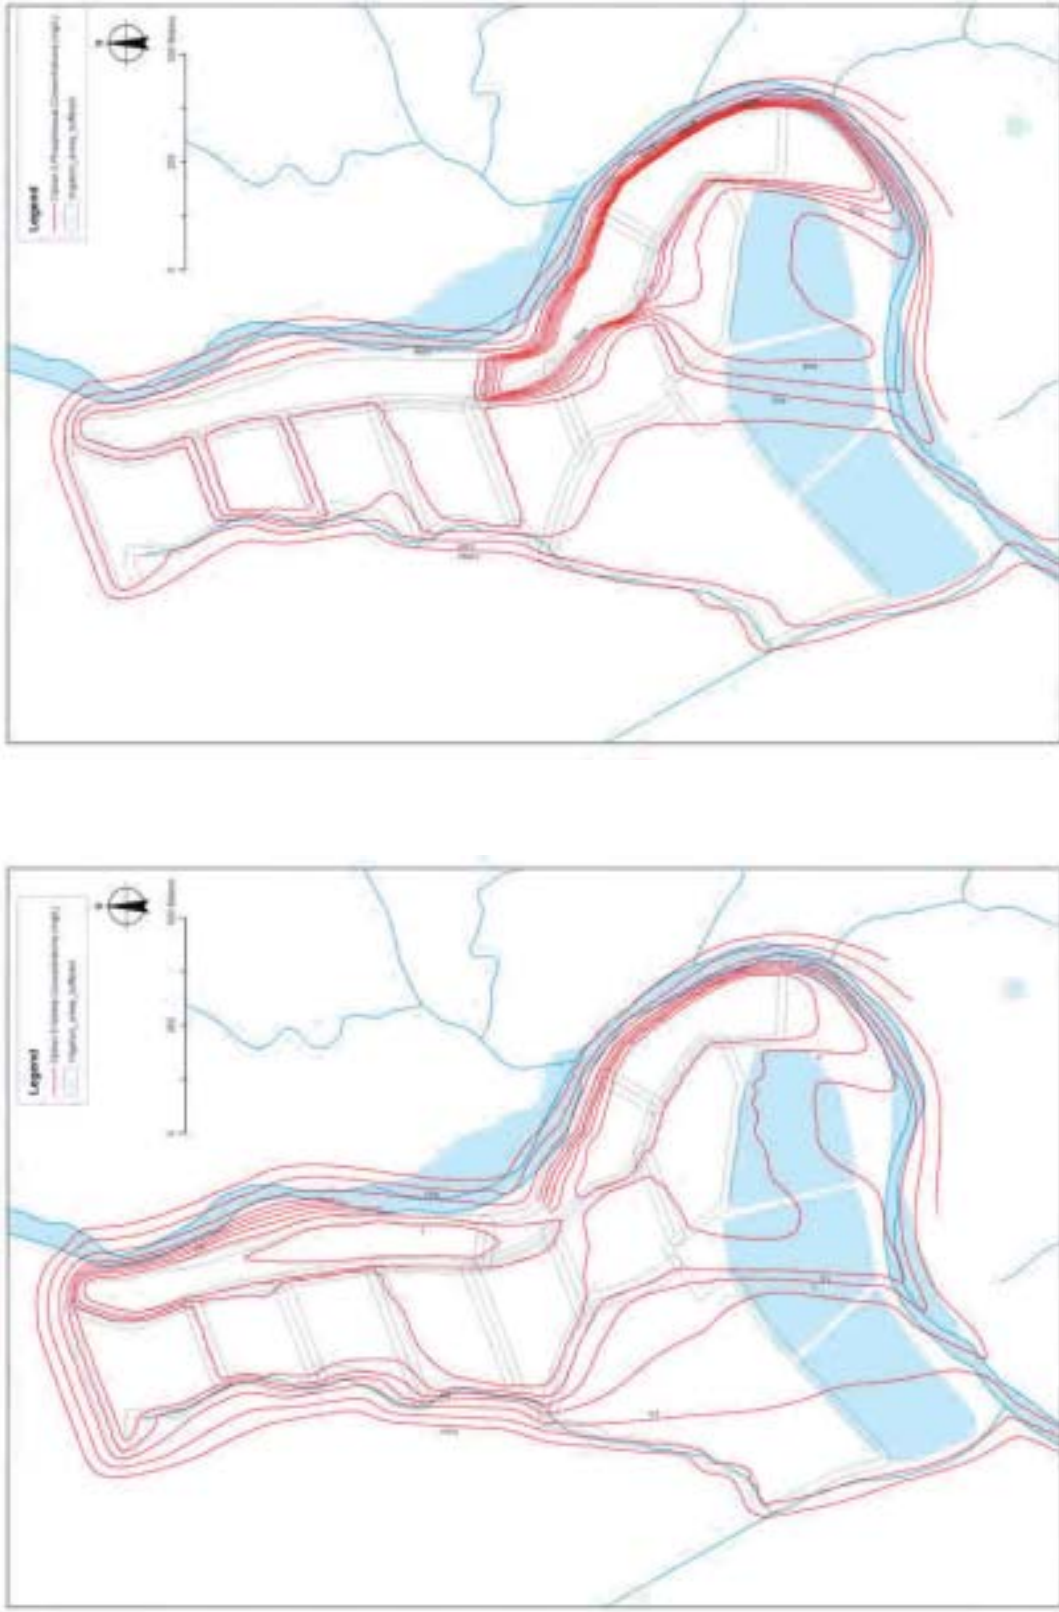
Figure 19: Plots of modelled nitrate and phosphorous concentrations for Option 3
